HISTORIC RESOURCES INVENTORY
BUILDING AND STRUCTURES
 HIST-6 NEW 5/77

1. BUILDING NAME (Common)	(Historic)	
ELLIOTT JOSLIN HOUSE		
2. TOWN CITY	VILLAGE	COUNTY
THOMPSON	EAST THOMPSON	WINDHAM
3. STREET AND NUMBER (and/or location)		
692 SAND DAM ROAD (343 SAND DAM RD.)		133 & 135/1-2
4. OWNER(S)		
DION, VIOLA, RRL, THOMPSON, CT 06277		
5. USE (Present)		
Residence		(Historic) Residence
6. ACCESSIBILITY TO PUBLIC:		
EXTERIOR VISIBLE FROM PUBLIC ROAD	INTERIOR ACCESSIBLE	IF YES, EXPLAIN
<input checked="" type="checkbox"/> Yes <input type="checkbox"/> No	<input type="checkbox"/> Yes <input checked="" type="checkbox"/> No

7. STYLE OF BUILDING	DATE OF CONSTRUCTION
Greek Revival	c. 1850

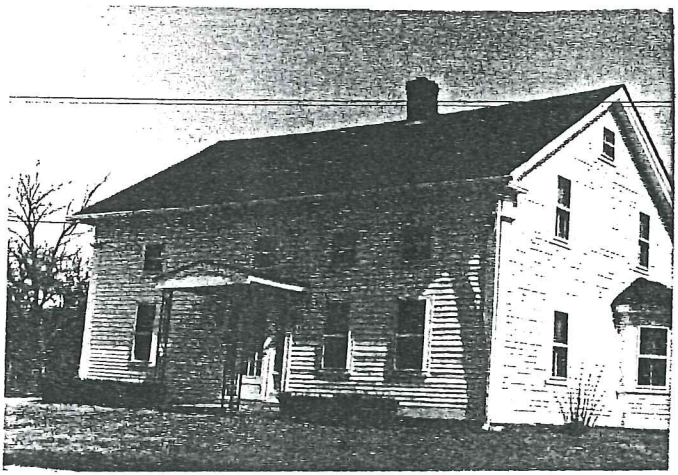
PHOTO	PHOTOGRAPHER Mark McDonough		DATE 1986
	VIEW NW	NEGATIVE ON FILE J21	
COMPILED BY	NAME Mark McDonough		DATE 1986
	ORGANIZATION Town of Thompson, Connecticut		
	ADDRESS

12. CONDITION (Structural)		(Exterior)	
<input type="checkbox"/> Excellent	<input checked="" type="checkbox"/> Good	<input type="checkbox"/> Excellent	<input checked="" type="checkbox"/> Good
<input type="checkbox"/> Fair	<input type="checkbox"/> Deteriorated	<input type="checkbox"/> Fair	<input type="checkbox"/> Deteriorated

13. INTEGRITY (Location)		WHEN ?	(Alterations)	IF YES, EXPLAIN
<input checked="" type="checkbox"/> On original site	<input type="checkbox"/> Moved		<input checked="" type="checkbox"/> Yes <input type="checkbox"/> No	New entry portico

Four bay facade, entry in second bay under gabled hood on modern "wrought-iron" steel supports. Entry has sidelights, door with single large pane over panels. Paneled entry pilasters and transom bar; plain corner blocks, paneled central tablet. Sash generally 2-over-2. Irregular bay spacing. Small frieze band windows with 3-over-3 sash. Wide plain pilasters, wide plain frieze with central molding. Molded cornice shows partial return.

Left elevation plain; right elevation has Victorian bay window at rear.
