**HISTORIC RESOURCES INVENTORY**  
**BUILDING AND STRUCTURES**  
 HIST-6 NEW 5/77

IDENTIFICATION	1. BUILDING NAME (Common) <span style="float: right;">(Historic)</span>		MARCUS L. RANDALL HOUSE	
	2. TOWN CITY		VILLAGE	COUNTY
	THOMPSON		QUADDICK	WINDAM

3. STREET AND NUMBER (and/or location)			145/14-5
	229 QUADDICK ROAD (437 QUADDICK RO.)			
	4. OWNER(S)			
	BARKER, ISABEL c/o Thelma Barker			
	RR 2, Thompson, CT 06277		<input type="checkbox"/> Public <input checked="" type="checkbox"/> Private

2. TOWN CITY THOMPSON VILLAGE QUADDICK COUNTY WINDHAM

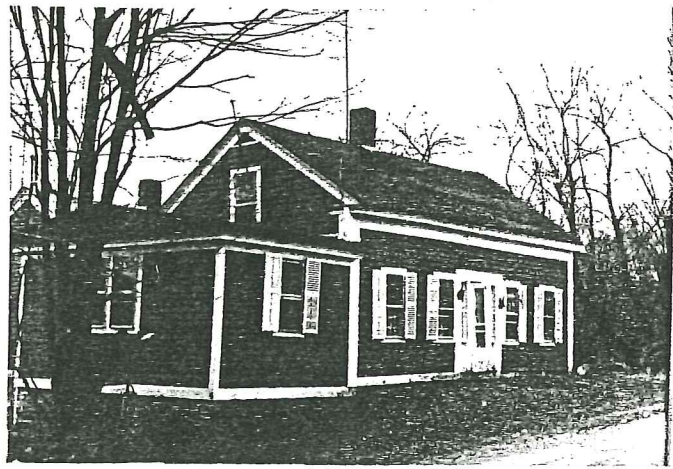
PHOTO	PHOTOGRAPHER Mark McDonough	DATE 1986
	VIEW SW	NEGATIVE ON FILE I26
COMPILED BY	NAME Mark McDonough	DATE 1986
	ORGANIZATION Town of Thompson, Connecticut	
	ADDRESS

11. NUMBER OF STORIES		APPROXIMATE DIMENSIONS		
1 1/2		33' x 18'		
12. CONDITION (structural) <span style="float: right;">(exterior)</span>				
<input type="checkbox"/> Excellent <input type="checkbox"/> Good <input checked="" type="checkbox"/> Fair <input type="checkbox"/> Deteriorated <input type="checkbox"/> Excellent <input type="checkbox"/> Good <input checked="" type="checkbox"/> Fair <input type="checkbox"/> Deteriorated

Five-bay facade, central entry, second and third bays grouped close to entry. Sash old 12-over-12. Entry has very wide plain board surround, crude heavy paneled door, rectangular sidelights over panels. Very wide plain pilasters and frieze.

Molded cornice shows partial return. Single brick chimney offset left. Left elevation has one story single-bay wing; old if not original. Side elevations have 2-over-2 sash.

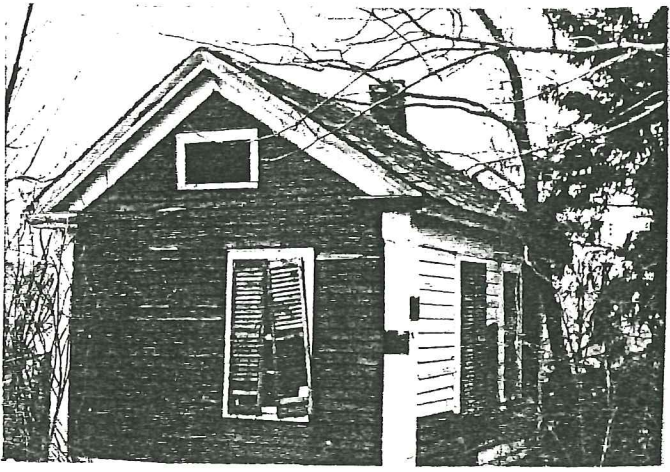
PHOTO	PHOTOGRAPHER Mark McDonough		DATE 1986
	VIEW NE	NEGATIVE ON FILE I27	
COMPILED BY	NAME Mark McDonough		DATE 1986
	ORGANIZATION Town of Thompson, Connecticut		
	ADDRESS

Small structure built gable-end-to-street on steep downslope. North (street-facing) elevation has single window offset right, old 6-over-6 with old wooden shutters. Rectangular attic window has no sash. Wide plain corner pilasters, plain wide frieze. Molded cornice shows partial return.

East (left) elevation has two windows with massive plain projecting frames, entry on raised basement level. South (rear) elevation has single window, brick chimney near end of ridge. West (right) elevation similar to east.
