HISTORIC RESOURCES INVENTORY
BUILDING AND STRUCTURES
 HIST-6 NEW 5/77

1. BUILDING NAME (Common)		(Historic)	
2. TOWN CITY	VILLAGE	COUNTY	
THOMPSON	NORTH GROSVENORDALE	WINDHAM	
3. STREET AND NUMBER (and/or location)		169/91-21	
160 MAIN STREET		DEMOLISHED - 1987	
4. OWNER(S)		<input checked="" type="checkbox"/> Public <input type="checkbox"/> Private	
TOWN OF THOMPSON			
5. USE (Present)		(Historic)	
Residence		Residence	
6. ACCESSIBILITY TO PUBLIC:		IF YES, EXPLAIN	
EXTERIOR VISIBLE FROM PUBLIC ROAD		INTERIOR ACCESSIBLE	
<input type="checkbox"/> Yes <input type="checkbox"/> No		<input type="checkbox"/> Yes <input type="checkbox"/> No

7. STYLE OF BUILDING		DATE OF CONSTRUCTION	
Victorian Vernacular		c. 1890	
8. MATERIAL(S) (Indicate use or location when appropriate)			
<input type="checkbox"/> Clapboard	<input type="checkbox"/> Asbestos Siding	<input type="checkbox"/> Brick	<input type="checkbox"/> Other (Specify)
<input type="checkbox"/> Wood Shingle	<input checked="" type="checkbox"/> Asphalt Siding	<input type="checkbox"/> Fieldstone	
<input type="checkbox"/> Board & Batten	<input type="checkbox"/> Stucco	<input type="checkbox"/> Cobblestone	
<input type="checkbox"/> Aluminum S

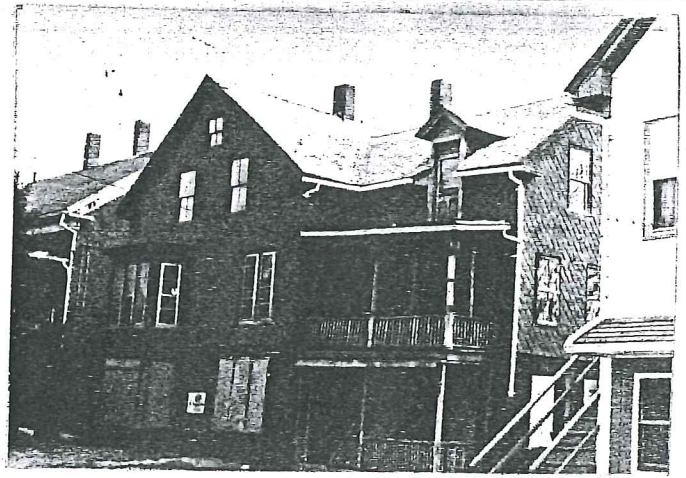
PHOTO	PHOTOGRAPHER Mark McDonough		DATE 1986
	VIEW NE	NEGATIVE ON FILE A8	
COMPILED BY	NAME Mark McDonough		DATE 1986
	ORGANIZATION Town of Thompson, Connecticut		
	ADDRESS

11. NUMBER OF STORIES		APPROXIMATE DIMENSIONS	
2 1/2		42' X 30'	
12. CONDITION (Structural)			
<input type="checkbox"/> Excellent <input type="checkbox"/> Good <input checked="" type="checkbox"/> Fair <input type="checkbox"/> Deteriorated		(Exterior) <input type="checkbox"/> Excellent <input type="checkbox"/> Good <input type="checkbox"/> Fair <input checked="" type="checkbox"/> Deteriorated

Two-bay, two-and-one-half-story front facing gable; slightly lower gabled right wing. Front gable: left bay has two-story flat-roofed bay window with bracketed molded cornice. First floor of bay has one large pane under a stained-glass panel; other sash generally mixed 2-over-2 and narrow 1-over-1 (most doors and windows now boarded). Molded cornice shows partial return.

Right wing: primarily 2-over-2 sash; first and second-floor entries. Two-story flat-roofed porch. Porch detailing: turned posts, jigsawn post brackets, square balusters and molded rail. Porch is badly deteriorated. Gabled wall dormer above porch contains entry; door has one large pane over panels.

Left elevation has two-story flat-roofed bay window. Right elevation has side entry sheltered by hood on consoles with star-and-vine cut-outs, turned pendants.

Architecturally, it is sadly deteriorated. The bracketed bay windows, porch detailing, and entry hood are all typical of Victorian Vernacular construction, which emphasized the use of elaborate wooden decoration made affordable by 19th-century advance in wood-forming technology.
