HISTORIC RESOURCES INVENTORY
BUILDING AND STRUCTURES
 HIST-6 NEW 5-77

IDENTIFICATION	1. BUILDING NAME (Common) _____ (Historic) _____	
	2. TOWN CITY THOMPSON	VILLAGE QUINEBAUG
	3. STREET AND NUMBER (and/or location) 104 ROUTE 197 (158 OLD TURNPIKE) 3/77-1

6. ACCESSIBILITY TO PUBLIC: <input checked="" type="checkbox"/> Yes <input type="checkbox"/> No INTERIOR ACCESSIBLE: <input type="checkbox"/> Yes <input checked="" type="checkbox"/> No IF YES, EXPLAIN _____	
DESCRIPTION	7. STYLE OF BUILDING Victorian Vernacular	
	DATE OF CONSTRUCTION c. 1880

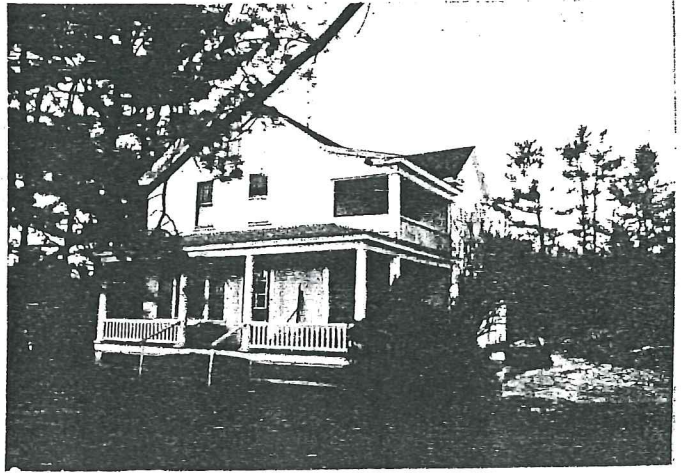
PHOTO	PHOTOGRAPHER	DATE
	Mark McDonough	1986
COMPILED BY	VIEW	NEGATIVE ON FILE
	W	H27
	NAME	DATE
Mark McDonough	1986	
ORGANIZATION	Town of Thompson, Connecticut	
ADDRESS

11. NUMBER OF STORIES APPROXIMATE DIMENSIONS 2 1/2 28' x 28'		
12. CONDITION (Interior) _____ (Exterior) _____ <input type="checkbox"/> Excellent <input checked="" type="checkbox"/> Good <input type="checkbox"/> Fair <input type="checkbox"/> Deteriorated <input type="checkbox"/> Excellent <input type="checkbox"/> Good <input checked="" type="checkbox"/> Fair <input type="checkbox"/> Deteriorated

13. INTEGRITY (Location) _____ WHEN? _____ (Alterations) _____ IF YES, EXPLAIN _____ <input checked="" type="checkbox"/> On original site <input type="checkbox"/> Moved <input checked="" type="checkbox"/> Yes <input type="checkbox"/> No Later sash, porch

Two-bay facade, right entry. Most visible fabric c. 1920, including sash with three narrow vertical panes over one. Plain narrow corner pilasters with molded capitals. Molded cornice shows partial return. Full width porch on Tuscan columns wraps left to meet two story gabled bay window. Small second floor porch adjoins front wall of bay window.

Left elevation: one story bay window. Lower parallel rear wing.
