HISTORIC RESOURCES INVENTORY
BUILDING AND STRUCTURES
 HIST-6 NEW 5/77

IDENTIFICATION	1. BUILDING NAME (Common) (Historic)		ABNER DAVIS 2nd HOUSE	
	2. TOWN CITY	VILLAGE	COUNTY	
	THOMPSON	WEST THOMPSON	WINDHAM	
	3. STREET AND NUMBER (and/or location)		48/104-9	
	770 WEST THOMPSON ROAD (396 W. THOMPSON Rd.)

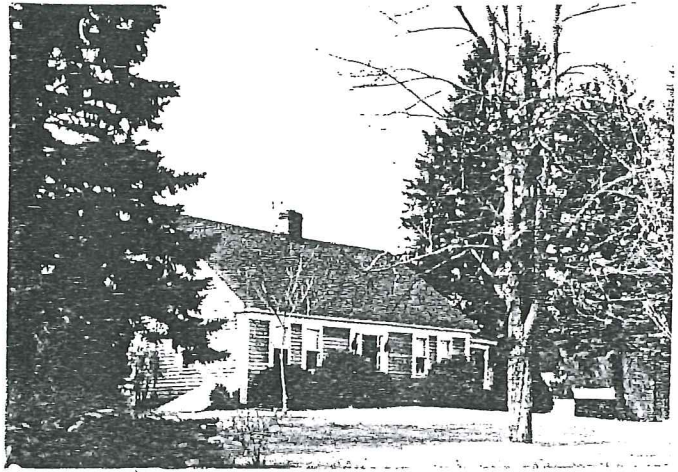
PHOTO	PHOTOGRAPHER Mark McDonough		DATE 1986
	VIEW NE	NEGATIVE ON FILE K23	
COMPILED BY	NAME Mark McDonough		DATE 1986
	ORGANIZATION Town of Thompson, Connecticut		
	ADDRESS

Five-bay facade, central entry. Sash generally 1-over-1. Entry has sidelights, wide plain surround. Wide plain frieze, plain corner pilasters, molded cornice with partial return. Clapboard recent. Single brick chimney offset slightly to right.

Right elevation has c. 1890 porch with turned posts, jigsaw brackets. Lower partial right wing at rear, very plain with old 6-over-6 sash, recent garage addition at right end.
