**HISTORIC RESOURCES INVENTORY**  
**BUILDING AND STRUCTURES**  
 HIST-6 NEW 5/77

IDENTIFICATION	1. BUILDING NAME (Common) <span style="float: right;">(Historic)</span>		GEORGE E. ELLIOTT HOUSE	
	2. TOWN CITY	VILLAGE	COUNTY	
	THOMPSON	GROSVENORDALE	WINDHAM

3. STREET AND NUMBER (and/or location)		63/98-4	
	64 BLAIN ROAD <span style="margin-left: 50px;">(28 BLAIN RD.)</span>			
	4. OWNER(S)		ST. JUDE MISSION	
	BERNARD, WILFRED, 1404 COLLEGE AVE., ALAMOGORDO, NEW MEXICO 88310		<input type="checkbox"/> Public	<input checked="" type="checkbox"/> Private

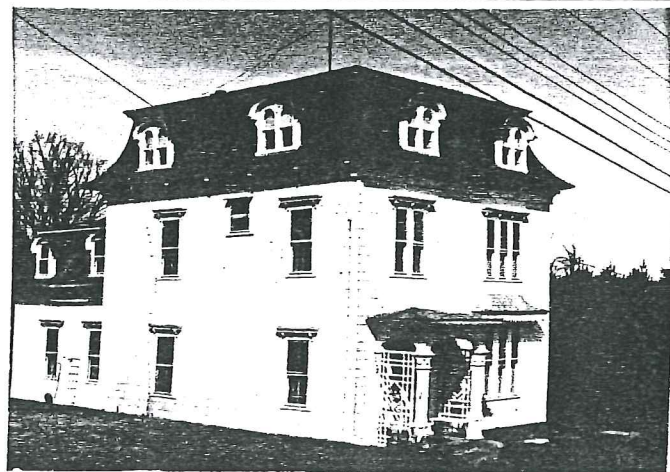
PHOTO	PHOTOGRAPHER	DATE
	Mark McDonough	1986
COMPILED BY	VIEW	NEGATIVE ON FILE
	NE	K12
	NAME	DATE
	Mark McDonough	1986
	ORGANIZATION	
	Town of Thompson, Connecticut	
	ADDRESS

13. INTEGRITY (Location)		WHEN?	(Alterations)	
<input checked="" type="checkbox"/> On original site	<input type="checkbox"/> Moved		<input checked="" type="checkbox"/> Yes <input type="checkbox"/> No	
			Later siding, most sash recent

Two-bay facade, left entry under flat roofed portico. Double narrow wood doors have large rectangular panes. Portico is on square chamfered posts with incised slots and circles. Bases have applied spade-like decorations. Capitals have applied leaf-in-circle decorations. Chamfered frieze forms shallow pointed arched openings. Molded cornice on small jigsaw brackets.

Above entry, paired windows, 1-over-1 sash, flat molded cap on jigsaw brackets with incised vine motif. Similar triple window to right; first floor right triple window has flared cap with fleur-de-lis motif valence. Overhanging eaves, plain architrave, scalloped frieze, large jigsaw brackets with paneled edges, incised vine motif.

Flared mansard roof with round arched roof dormers with paired, round arched windows. One-and-one-half-story rear wing with similar detailing.
