HISTORIC RESOURCES INVENTORY
BUILDING AND STRUCTURES
 HIST-6 NEW 5/77

IDENTIFICATION	1. BUILDING NAME (Common) (Historic) CHARLES C. CARPENTER HOUSE	
	2. TOWN CITY THOMPSON	VILLAGE GROSVENORDALE
	3. STREET AND NUMBER (and/or location) 146 BLAIN ROAD <i>54 Blain Rd.</i>

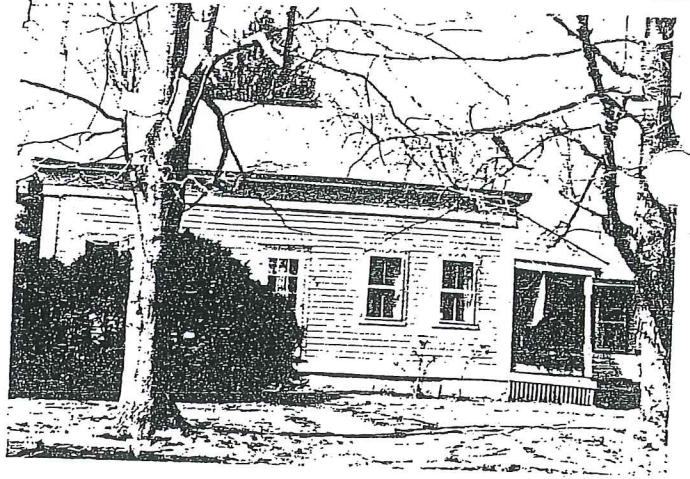
PHOTO	PHOTOGRAPHER Mark McDonough		DATE 1986
	VIEW N	NEGATIVE ON FILE K13	
COMPILED BY	NAME Mark McDonough		DATE 1986
	ORGANIZATION Town of Thompson, Connecticut		
	ADDRESS		
16 SUBSEQUENT FIELD EVALUATION

11. NUMBER OF STORIES APPROXIMATE DIMENSIONS		
1 1/2 30' x 22'		
12. CONDITION (Structural) (Exterior)		
<input type="checkbox"/> Excellent <input checked="" type="checkbox"/> Good <input type="checkbox"/> Fair <input type="checkbox"/> Deteriorated <input type="checkbox"/> Excellent <input checked="" type="checkbox"/> Good <input type="checkbox"/> Fair <input type="checkbox"/> Deteriorated

13. INTEGRITY (Location) WHEN ? (Alterations) IF YES, EXPLAIN		
<input checked="" type="checkbox"/> On original site <input type="checkbox"/> Moved <input checked="" type="checkbox"/> Yes <input type="checkbox"/> No Modern storm sash, front porch removed

Five-bay facade, central entry. Sash generally 2-over-2. Wood door c. 1920 with modified border pane glazing. Plain corner pilasters. Plain frieze with central molding. Molded cornice shows partial return.

Lower one-and-one-half-story right ell with similar detailing, side entry. Right elevation has small shed roofed porch on turned posts.
