HISTORIC RESOURCES INVENTORY
BUILDING AND STRUCTURES
HIST-6 NEW 5/77

1. BUILDING NAME (Common)		(Historic)	
CHARLES W. WEBSTER HOUSE			
2. TOWN CITY	VILLAGE	COUNTY	
THOMPSON	WILSONVILLE	WINDHAM	
3. STREET AND NUMBER (and/or location)		77/62-61	
857 WILSONVILLE ROAD (65-69 WILSONVILLE RD)

7. STYLE OF BUILDING		DATE OF CONSTRUCTION	
Greek Revival		c. 1845	
8. MATERIAL(S) (Indicate use or location when appropriate)			
<input checked="" type="checkbox"/> Clapboard	<input type="checkbox"/> Asbestos Siding	<input checked="" type="checkbox"/> Chimney Brick	<input type="checkbox"/> Other (Specify) _____
<input type="checkbox"/> Wood Shingle	<input type="checkbox"/> Asphalt Siding	<input checked="" type="checkbox"/> Fieldstone	Foundation
<input type="checkbox"/> Board & Batten	<input type="checkbox"/> Stucco	<input type="checkbox"/> Cobblestone	
<input type="checkbox"/> Aluminum Siding	<input type="checkbox"/> Concrete Type: _____	<input type="checkbox"/> Cut stone Type: _____

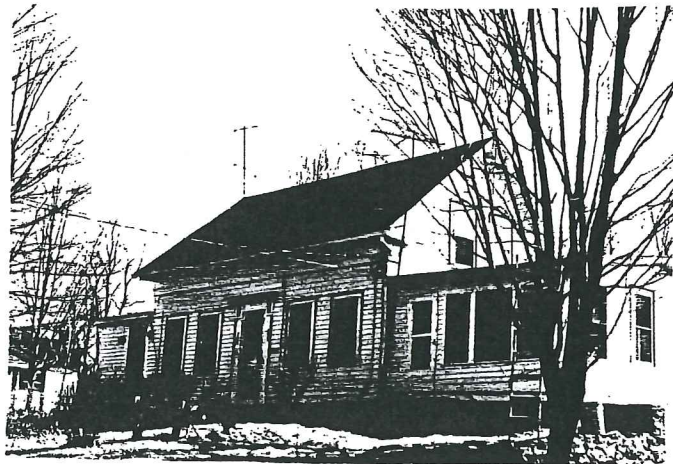
PHOTO	PHOTOGRAPHER Mark McDonough		DATE 1986
	VIEW SE	NEGATIVE ON FILE L35	
COMPILED BY	NAME Mark McDonough		DATE 1986
	ORGANIZATION Town of Thompson, Connecticut		
	ADDRESS

DESCRIPTION	17 OTHER NOTABLE FEATURES OF BUILDING OR SITE (interior and/or exterior)		
	<p>Five-bay facade, central entry, sash generally 2-over-2. Entry has paneled pilasters and lintel with paneled rectangular corner blocks. Door has twin round-arched lights cover rectangular panels. Narrow corner pilasters.</p> <p>Molded architrave, plain frieze; molded cornice shows partial return. Left elevation has small flat-roofed 20th century addition. Right has old lower parallel wing with modern framed-in porch.</p>
