HISTORIC RESOURCES INVENTORY
BUILDING AND STRUCTURES
 HIST-6 NEW 5/77

1. BUILDING NAME (Common)		(Historic)	
2. TOWN CITY	VILLAGE	COUNTY	
THOMPSON	WILSONVILLE	WINDHAM	
3. STREET AND NUMBER (and/or location)		77/63-2	
986 WILSONVILLE ROAD (6 WILSONVILLE RD.)

7. STYLE OF BUILDING		DATE OF CONSTRUCTION	
Greek Revival		c. 1845	
8. MATERIAL(S) (Indicate use or location when appropriate)			
<input checked="" type="checkbox"/> Clapboard	<input type="checkbox"/> Asbestos Siding	<input checked="" type="checkbox"/> Chimneys	<input type="checkbox"/> Other (Specify)
<input type="checkbox"/> Wood Shingle	<input type="checkbox"/> Asphalt Siding	<input checked="" type="checkbox"/> Fieldstone	Foundation
<input type="checkbox"/> Board & Batten	<input type="checkbox"/> Stucco	<input type="checkbox"/> Cobblestone	
<input type="checkbox"/> Aluminum Siding	<input type="checkbox"/> Concrete Type:	<input type="checkbox"/> Cut stone	Type:

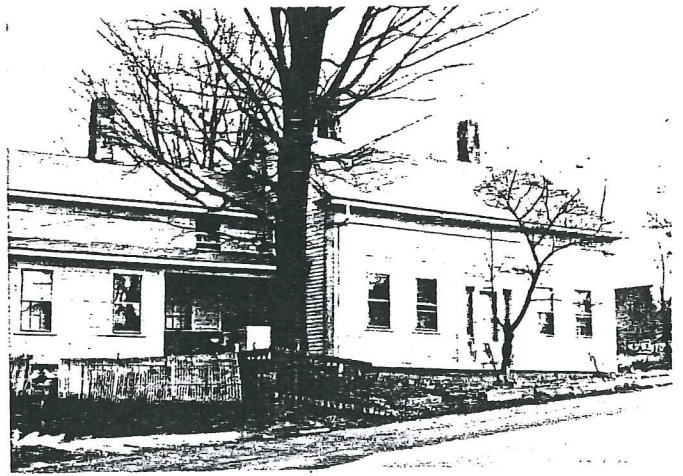
PHOTO	PHOTOGRAPHER Mark McDonough	DATE 1986
	VIEW NE	NEGATIVE ON FILE F13
COMPILED BY	NAME Mark McDonough	DATE 1986
	ORGANIZATION Town of Thompson, Connecticut	
	ADDRESS

11. NUMBER OF STORIES	APPROXIMATE DIMENSIONS		
1 1/2	34' X 24' (main part)		
12. CONDITION (Structural)		(Exterior)	
<input type="checkbox"/> Excellent <input type="checkbox"/> Good <input checked="" type="checkbox"/> Fair <input type="checkbox"/> Deteriorated	<input type="checkbox"/> Excellent <input type="checkbox"/> Good <input checked="" type="checkbox"/> Fair <input type="checkbox"/> Deteriorated

Five-bay main wing, central entry. Paneled wood door flanked by rectangular sidelights over panels. Paneled entry surround with paneled corner blocks. Sash old 6-over-6. Plain corner pilasters with molded capitals, plain frieze. Molded cornice shows partial return.

Twin brick chimneys. Lower parallel left wing, four bays. Shed roofed porch is framed-in at left. To right is semi-detached shed (appears to be outhouse).
