HISTORIC RESOURCES INVENTORY
BUILDING AND STRUCTURES
 HIST-6 NEW 5/77

1. BUILDING NAME (Common) _____ (Historic) **DYER UPHAM HOUSE**

3. STREET AND NUMBER (and/or location): **976 WILSONVILLE ROAD** (12 WILSONVILLE RD.)

7. STYLE OF BUILDING: **Greek Revival** DATE OF CONSTRUCTION: **c. 1850**

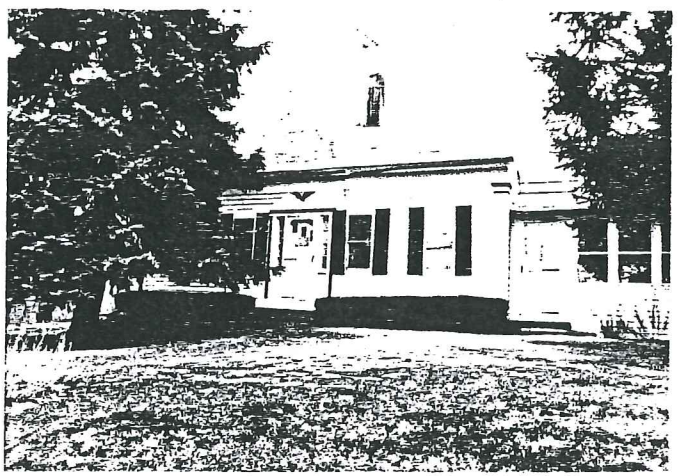
PHOTO	PHOTOGRAPHER Mark McDonough		DATE 1986
	VIEW NW	NEGATIVE ON FILE F14	
COMPILED BY	NAME Mark McDonough		DATE 1986
	ORGANIZATION Town of Thompson, Connecticut		
	ADDRESS

13. INTEGRITY (Location) On original site Moved WHEN? _____ (Alterations) Yes No IF YES, EXPLAIN: **modern windows, later porch**

Five-bay main wing with central entry. C. 1850 wood door flanked by sidelights over panels. Plain corner pilasters with molded capitals, plain frieze, molded cornice shows partial return.

Central stucco chimney. Lower parallel right wing with 20th-century framed-in porch.
