STATE OF CONNECTICUT  
**CONNECTICUT HISTORICAL COMMISSION**  
 59 SOUTH PROSPECT STREET, HARTFORD, CONNECTICUT 06106  
 (203) 566-3005

1. BUILDING NAME (Common) _____ (Historic) _____	
2. TOWN CITY THOMPSON	VILLAGE THOMPSON
3. STREET AND NUMBER (and/or location) 416 ROUTE 200 (166 THOMPSON HILL RD.) 83/43-16A

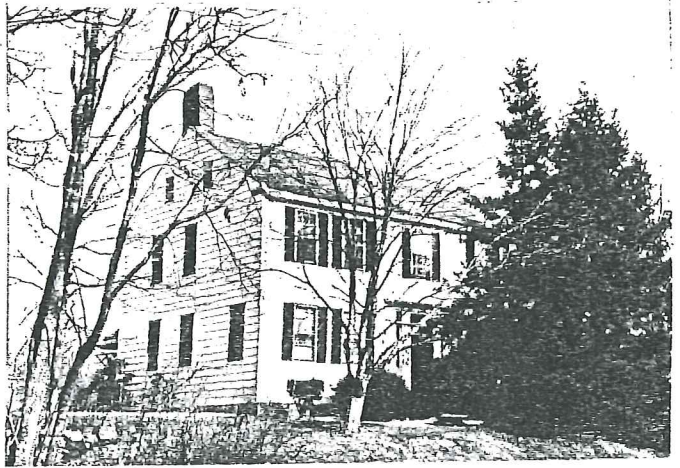
11. NUMBER OF STORIES 2 1/2	APPROXIMATE DIMENSIONS 38' x 25'
12. CONDITION (Structural) _____ (Exterior) _____	
<input type="checkbox"/> Excellent <input checked="" type="checkbox"/> Good <input type="checkbox"/> Fair <input type="checkbox"/> Deteriorated	<input type="checkbox"/> Excellent <input checked="" type="checkbox"/> Good <input type="checkbox"/> Fair <input type="checkbox"/> Deteriorated

PHOTO	PHOTOGRAPHER Mark McDonough		DATE 1986
	VIEW NE	NEGATIVE ON FILE E5	
COMPILED BY	NAME Mark McDonough		DATE 1986
	ORGANIZATION Town of Thompson, Connecticut		
	ADDRESS

Five-bay facade, paired and offset window bays, second floor windows fitted into bed molding. Sash generally 6-over-6 with some 2-over-2. Central entry has heavy paneled wood door, rectangular sidelights flanked by narrow paneled pilasters. Glazed transom above molded transom bar. Flat molded cap above. Single brick chimney at left. Side elevations plain, small paired attic louvers.
