**HISTORIC RESOURCES INVENTORY**  
**BUILDING AND STRUCTURES**  
 HIST-6 NEW 5-77

STATE OF CONNECTICUT  
**CONNECTICUT HISTORICAL COMMISSION**  
 59 SOUTH PROSPECT STREET, HARTFORD, CONNECTICUT 06106  
 (203) 566-3005

IDENTIFICATION	1. BUILDING NAME (Common) _____ (Historic) _____	
	2. TOWN CITY THOMPSON	VILLAGE THOMPSON
	3. STREET AND NUMBER (and/or location) 390 ROUTE 200 (182 THOMPSON HILL RD.) 83/43-17

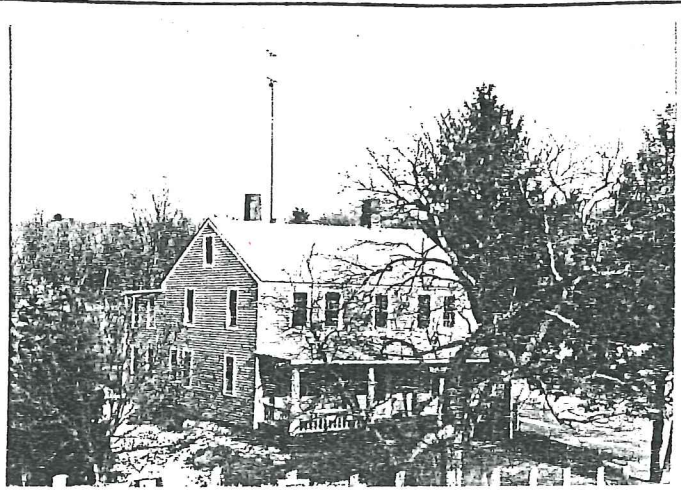
PHOTO	PHOTOGRAPHER Mark McDonough		DATE 1986
	VIEW NE & NE	NEGATIVE ON FILE E6 & E7	
COMPILED BY	NAME Mark McDonough		DATE 1986
	ORGANIZATION Town of Thompson, Connecticut		
	ADDRESS

Five-bay facade, central entry. Recent wood door. Window bays paired and offset towards corners of house. Sash mixed 1-over-1 and 6-over-6. Full width one story porch on fluted Doric columns has cut-out-slat rail.

Second floor windows located relatively high under the eaves. Cornice detail obscured by modern siding. Twin brick chimneys. Two story shed-roofed rear addition.

Detached barn to right has fieldstone foundation, old wood shingles, overhangs at second floor, gable ends.
