**HISTORIC RESOURCES INVENTORY**  
**BUILDING AND STRUCTURES**  
 HIST-6 NEW 5/77

IDENTIFICATION	1. BUILDING NAME (Common) <i>(Historic)</i>	
	2. TOWN CITY THOMPSON	VILLAGE THOMPSON
	3. STREET AND NUMBER (and/or location) 450 ROUTE 200 <i>(150 THOMPSON HILL RD.)</i>

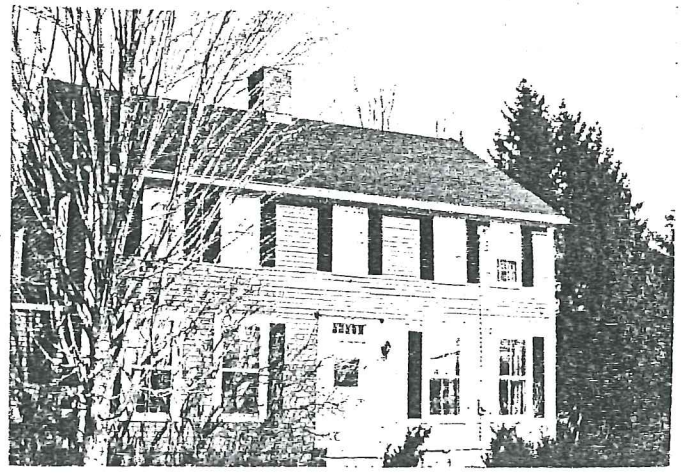
PHOTO	PHOTOGRAPHER Mark McDonough		DATE 1986
	VIEW NE	NEGATIVE ON FILE E4	
COMPILED BY	NAME Mark McDonough		DATE 1986
	ORGANIZATION Town of Thompson, Connecticut		
	ADDRESS

11. NUMBER OF STORIES   APPROXIMATE DIMENSIONS 2 1/2   36' x 26'	
	12. CONDITION (structural)   (Exterior) <input type="checkbox"/> Excellent <input checked="" type="checkbox"/> Good <input type="checkbox"/> Fair <input type="checkbox"/> Deteriorated   <input type="checkbox"/> Excellent <input checked="" type="checkbox"/> Good <input type="checkbox"/> Fair <input type="checkbox"/> Deteriorated

Five-bay facade, central entry. Entry has slender plain pilasters, rectangular glazed transom. Door is c. 1880 with single large pane over deeply molded panels. Sash generally 2-over-2. First floor windows oversized, second floor windows are located high under eaves, have some 6-over-6 sash. Bays paired and offset towards corners of house. Plain corner boards. Molded cornice shows partial return.

Central brick chimney. Right elevation has side entry in very wide plain board frame. Left elevation has old 12-over-8 sash in attic.
