**HISTORIC RESOURCES INVENTORY**  
**BUILDING AND STRUCTURES**  
 HIST-6 NEW 5/77

STATE OF CONNECTICUT  
**CONNECTICUT HISTORICAL COMMISSION**  
 59 SOUTH PROSPECT STREET, HARTFORD, CONNECTICUT 06106  
 (203) 566-3005

IDENTIFICATION	1. BUILDING NAME (Common)		(Historic) DAVID DAY HOUSE		
	2. TOWN CITY THOMPSON		VILLAGE THOMPSON	COUNTY WINDHAM	
	3. STREET AND NUMBER (and/or location) 268 BALLARD ROAD		(245 BALLARD RD.) 87/53-11

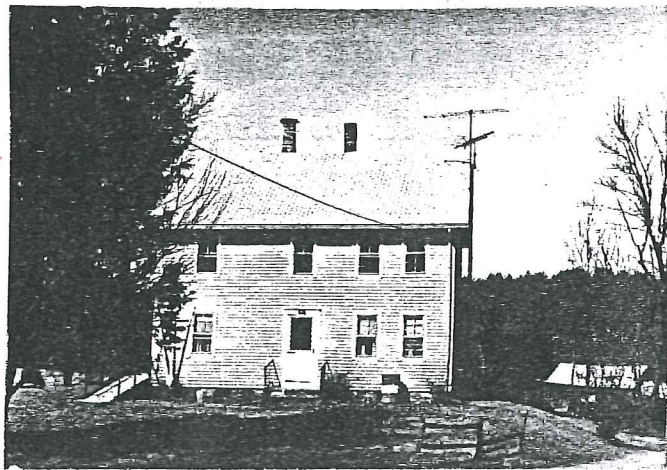
PHOTO	PHOTOGRAPHER Mark McDonough		DATE 1986
	VIEW N	NEGATIVE ON FILE K6	
COMPILED BY	NAME Mark McDonough		DATE 1986
	ORGANIZATION Town of Thompson, Connecticut		
	ADDRESS

Four-bay facade, entry in second. Right three bays grouped. Sash generally 2-over-2. Molded cornice, overhanging eaves, twin brick chimneys near center of ridge.

This highly altered house almost certainly dates to the 18th century. It may well have been expanded from a three-bay house sometime in the 19th century.
