HISTORIC RESOURCES INVENTORY
BUILDING AND STRUCTURES
 HIST-6 NEW 5/77

IDENTIFICATION	1. BUILDING NAME (Common) (Historic) WILLIAM W. HOLMES HOUSE	
	2. TOWN CITY THOMPSON	VILLAGE WILSONVILLE
	3. STREET AND NUMBER (and/or location) 370 WILSONVILLE ROAD (310 WILSONVILLE RD.) 97/44-4

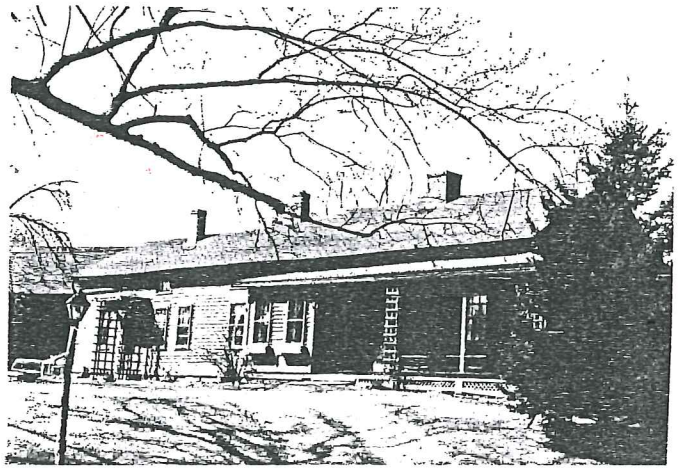
PHOTO	PHOTOGRAPHER Mark McDonough	DATE 1986
	VIEW NW	NEGATIVE ON FILE L28
COMPILED BY	NAME Mark McDonough	DATE 1986
	ORGANIZATION Town of Thompson, Connecticut	
	ADDRESS

Structure consists of two houses joined together. Left: old 6-over-6 sash, five bays, irregularly spaced. Entry in second bay. Paneled wood door. Early hood on jigsawn consoles.

Right: some old 6-over-6 sash, some 2-over-2. Three-bay facade. First is Victorian bay window, second is entry with border pane stained glass door. One story porch on square posts, jigsawn post brackets with turned circular bosses; porch continues across right elevation.

The left portion of the house, built about 1850, features a balloon frame of full dimensional lumber. The older right portion, which may date to the 18th century, has a heavy timber post-and-beam frame. The two structures are discrete, with a double sill where they are joined and completely separate roof framing. This makes it probable that one of the two buildings was moved to its current position, a common occurrence in the 19th century.
