HISTORIC RESOURCES INVENTORY
BUILDING AND STRUCTURES
 HIST-6 NEW 5-77

IDENTIFICATION	1. BUILDING NAME (Common) (Historic) IRVING L. JOHNSON HOUSE	
	2. TOWN CITY THOMPSON	VILLAGE THOMPSON
	3. STREET AND NUMBER (and/or location) 2172 ROUTE 193 (183 THOMPSON RO.)

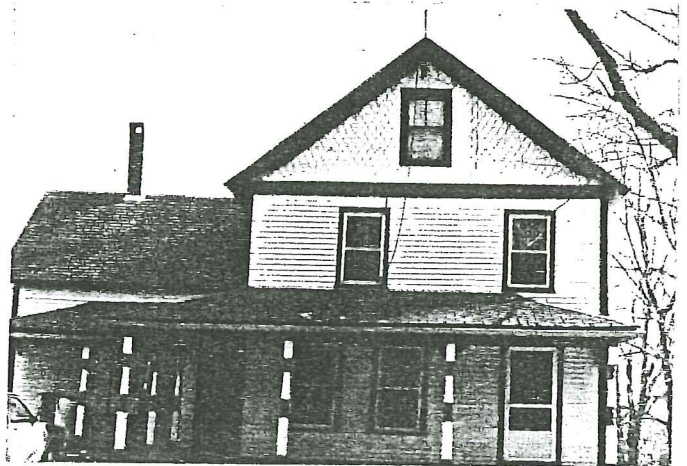
PHOTO	PHOTOGRAPHER Mark McDonough q		DATE 1986
	VIEW SE	NEGATIVE ON FILE G9	
COMPILED BY	NAME Mark McDonough		DATE 1986
	ORGANIZATION Town of Thompson, Connecticut		
	ADDRESS

11. NUMBER OF STORIES <input type="checkbox"/> APPROXIMATE DIMENSIONS		
2 1/2 20' X 30'		
12. CONDITION (Structural) (Exterior)		
<input type="checkbox"/> Excellent <input checked="" type="checkbox"/> Good <input type="checkbox"/> Fair <input type="checkbox"/> Deteriorated <input type="checkbox"/> Excellent <input checked="" type="checkbox"/> Good <input type="checkbox"/> Fair <input type="checkbox"/> Deteriorated

13. INTEGRITY (Location) WHEN ? (Alterations) IF YES, EXPLAIN		
<input checked="" type="checkbox"/> On original site <input type="checkbox"/> Moved <input checked="" type="checkbox"/> Yes <input type="checkbox"/> No modern storm sash, porch rail gone

Two bays over three with right entry. Door has a single large light over panels. One-story shed-roofed porch wraps around left corner to meet one-and-one-half-story ell. Porch has turned posts, small curved post brackets with carved sunbursts.

Prominent corner boards, wide plain window surrounds wide plain frieze topped by narrow molding across rake ends. Molded cornice, no return. Tympanum is slightly flared with diamond-patterned wood shingles. Left ell has similar detailing.
