**HISTORIC RESOURCES INVENTORY**  
**BUILDING AND STRUCTURES**  
 HIST-6 NEW 5/77

STATE OF CONNECTICUT  
**CONNECTICUT HISTORICAL COMMISSION**  
 59 SOUTH PROSPECT STREET, HARTFORD, CONNECTICUT 06106  
 (203) 566-3005

1. BUILDING NAME (Common) O'LEARY FARM	(Historic) JOHN MILLS HOUSE	
2. TOWN CITY THOMPSON	VILLAGE THOMPSON	COUNTY WINDHAM
3. STREET AND NUMBER (and/or location) 294 O'LEARY ROAD	(157 O'LEARY RD.)	141/16-21
4. OWNER(S) O'LEARY, ERNEST J. & NORMA R., RR2, THOMPSON, CT 06277	<input type="checkbox"/> Public	<input checked="" type="checkbox"/> Private
5. USE (Present) Residence	(Historic) Residence	
6. ACCESSIBILITY TO PUBLIC:	EXTERIOR VISIBLE FROM PUBLIC ROAD <input checked="" type="checkbox"/> Yes <input type="checkbox"/> No	INTERIOR ACCESSIBLE <input type="checkbox"/> Yes <input checked="" type="checkbox"/> No

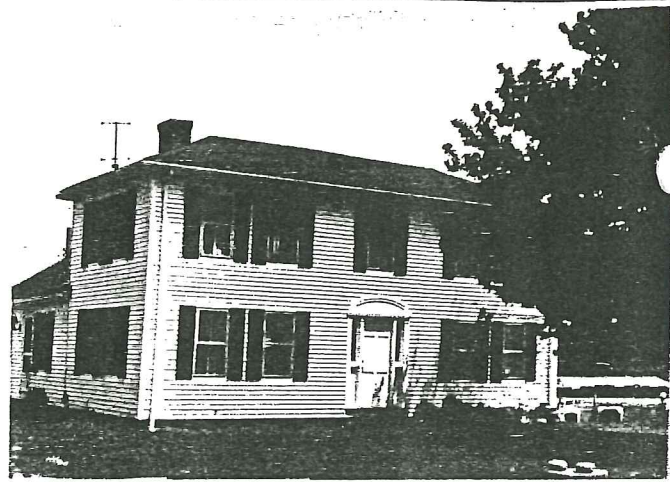
PHOTO	PHOTOGRAPHER Mark McDonough		DATE 1986
	VIEW NW	NEGATIVE ON FILE M16	
COMPILED BY	NAME Mark McDonough		DATE 1986
	ORGANIZATION Town of Thompson, Connecticut		
	ADDRESS

Five-bay facade, central entry. Window bays paired and offset. Second floor windows located relatively high under the eaves. Entry altered by later repairs. Rectangular sidelights, old heavy paneled door. Narrow fluted pilasters flank sidelights, outer pilasters paired.

Semi-elliptical carved sunburst above with molded surround. Overhanging eaves, sided cornice. Plain lower two story rear wing, old.

Architecturally, it is considerably altered, but is significant for the surviving Federal style trim seen in the entry. The Federal or Adam style, inspired by the work of England's Adam brothers, is characterized by the use of delicate, classically inspired detailing (seen here in the slender fluted entry pilasters and carved fan). It was most popular in Thompson between 1800 and 1815.
