STATE OF CONNECTICUT
CONNECTICUT HISTORICAL COMMISSION
 59 SOUTH PROSPECT STREET, HARTFORD, CONNECTICUT 06106
 (203) 566-3005

IDENTIFICATION	1. BUILDING NAME (Common) (Historic)		EMILY A. ROBINSON HOUSE		
	2. TOWN CITY THOMPSON		VILLAGE EAST THOMPSON	COUNTY WINDHAM	
	3. STREET AND NUMBER (and/or location)		152/1-64		
	272 EAST THOMPSON ROAD		(664 EAST THOMPSON RD.)

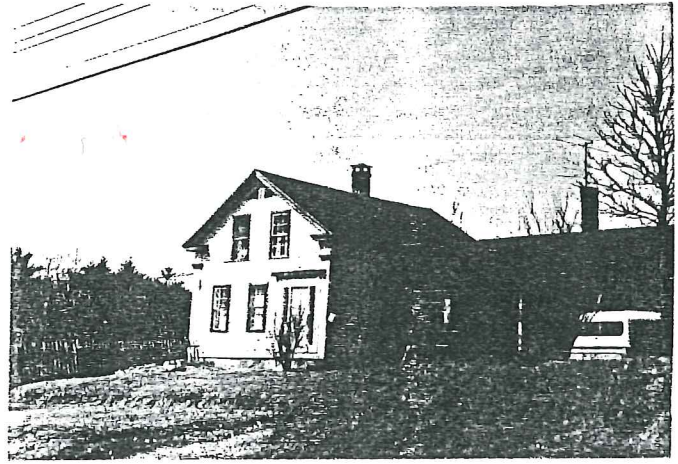
PHOTO	PHOTOGRAPHER Mark McDonough		DATE 1986
	VIEW NW	NEGATIVE ON FILE J19	
COMPILED BY	NAME Mark McDonough		DATE 1986
	ORGANIZATION Town of Thompson, Connecticut		
	ADDRESS

11. NUMBER OF STORIES		APPROXIMATE DIMENSIONS			
1 1/2		21' x 30' (main part) 26' x 14' (ell)			
12. CONDITION (Structural) (Exterior)					
<input type="checkbox"/> Excellent <input type="checkbox"/> Good <input checked="" type="checkbox"/> Fair <input type="checkbox"/> Deteriorated <input type="checkbox"/> Excellent <input type="checkbox"/> Good <input checked="" type="checkbox"/> Fair <input type="checkbox"/> Deteriorated

Three-bay facade, right entry. Sash generally old 6-over-6. Entry has rectangular sidelights over panels, paneled wood door. Paneled entry pilasters, wide plain frieze, molded cap. Paneled corner pilasters, plain frieze; molded cornice shows partial return. Paired attic windows. One story right ell with roof flared to form open porch on recent square timbers. Raised basement on downslope, left elevation has side entry.
