HISTORIC RESOURCES INVENTORY
BUILDING AND STRUCTURES
 HIST-6 NEW 5/77

IDENTIFICATION	1. BUILDING NAME (Common) _____ (Historic)	
	2. TOWN CITY THOMPSON	VILLAGE NORTH GROSVENORDALE
	3. STREET AND NUMBER (and/or location) 81 BUCKLEY HILL ROAD (37 BUCKLEY HILL RD.) 167/59-10

6. ACCESSIBILITY TO PUBLIC: <input checked="" type="checkbox"/> Yes <input type="checkbox"/> No	
	7. STYLE OF BUILDING Mill Housing	
	DATE OF CONSTRUCTION c. 1890

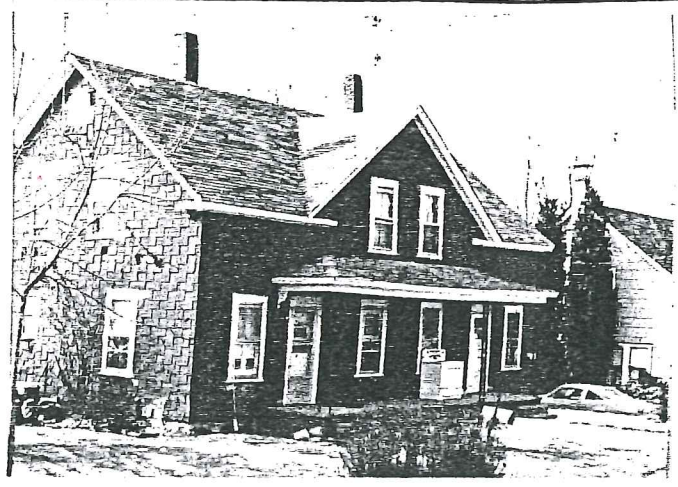
PHOTO	PHOTOGRAPHER Mark McDonough		DATE 1986
	VIEW SW	NEGATIVE ON FILE D18	
COMPILED BY	NAME Mark McDonough		DATE 1986
	ORGANIZATION Town of Thompson, Connecticut		
	ADDRESS

11. NUMBER OF STORIES APPROXIMATE DIMENSIONS	
	1 1/2 44' x 28'	
	12. CONDITION (Structural) _____ (Exterior)	
	<input type="checkbox"/> Excellent <input checked="" type="checkbox"/> Good <input type="checkbox"/> Fair <input type="checkbox"/> Deteriorated <input type="checkbox"/> Excellent <input type="checkbox"/> Good <input checked="" type="checkbox"/> Fair <input type="checkbox"/> Deteriorated

13. INTEGRITY (Location) _____ WHEN? _____ (Alterations) _____ IF YES, EXPLAIN	
	<input checked="" type="checkbox"/> On original site <input type="checkbox"/> Moved <input checked="" type="checkbox"/> Yes <input type="checkbox"/> No Later siding, storm sash.

Six-bay facade, entries in second and fifth. Doors have three horizontal panes over rectangular panels. Sash generally 2-over-2. One story porch, nearly full width on modern steel "wrought iron" posts, quarter-circle post brackets with radial cut-outs survive at left and right wall junctions.

Central gabled wall dormer with paired windows. Molded cornice shows partial return.
