**HISTORIC RESOURCES INVENTORY**  
**BUILDING AND STRUCTURES**  
 HIST-6 NEW 5/77

IDENTIFICATION	1. BUILDING NAME (Common)		(Historic)	
	NORTH GROSVENORDALE METHODIST CHURCH		FISHERVILLE METHODIST CHURCH	
	2. TOWN CITY	VILLAGE	COUNTY	
	THOMPSON	N. GROSVENORDALE	WINDHAM

#19 FISHERVILLE METHODIST CHURCH

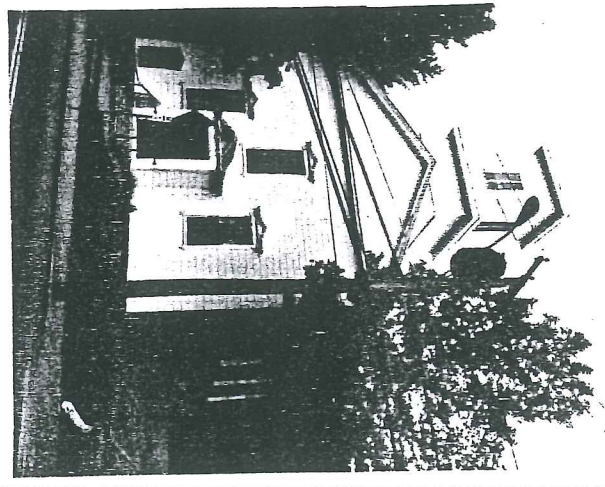
PHOTO	PHOTOGRAPHER Mark McDonough		DATE 1986
	VIEW SW	NEGATIVE ON FILE M3	
COMPILED BY	NAME Mark McDonough		DATE 1986
	ORGANIZATION Town of Thompson, Connecticut		
	ADDRESS

11. NUMBER OF STORIES		APPROXIMATE DIMENSIONS		
2 1/2		42' x 60'		
12. CONDITION (Structural)				
<input type="checkbox"/> Excellent	<input checked="" type="checkbox"/> Good	<input type="checkbox"/> Fair	<input type="checkbox"/> Deteriorated	
(Exterior)		<input type="checkbox"/> Excellent	<input checked="" type="checkbox"/> Good <input type="checkbox"/> Fair <input type="checkbox"/> Deteriorated

13. INTEGRITY (Location)		WHEN ?		
<input checked="" type="checkbox"/> On original site <input type="checkbox"/> Moved		(Alterations)		
		<input checked="" type="checkbox"/> Yes <input type="checkbox"/> No		
		IF YES, EXPLAIN		
		Sided facade & steeple

Facade clad in asbestos siding, steeple in aluminum. Side walls are common bond brick with occasional stretcher courses. Three-bay facade, central entry in small gabled vestibule with cornice on small jigsaw brackets. 15-over-15 sash left, right, and above entry. Windows have peaked, molded caps on small jigsaw consoles, small sill consoles. Sided cornice, pedimented peak.

Two stage rectangular steeple with flat roof, paired louvers. Side elevations have 10-over-10 basement sash with heavy stone sills and lintels, 15-over-15 main sash with same sills and lintels.
