**HISTORIC RESOURCES INVENTORY
BUILDING AND STRUCTURES**
HIST-6 NEW 5/77

1. BUILDING NAME (Common)		(Historic)	
NORTH GROSVENORDALE MILL HOUSING			
2. TOWN CITY	VILLAGE	COUNTY	
THOMPSON	NORTH GROSVENORDALE	WINDHAM	
3. STREET AND NUMBER (and/or location)			
1091 ROUTE 12 (938 RIVERSIDE DR.)		167/88-28A

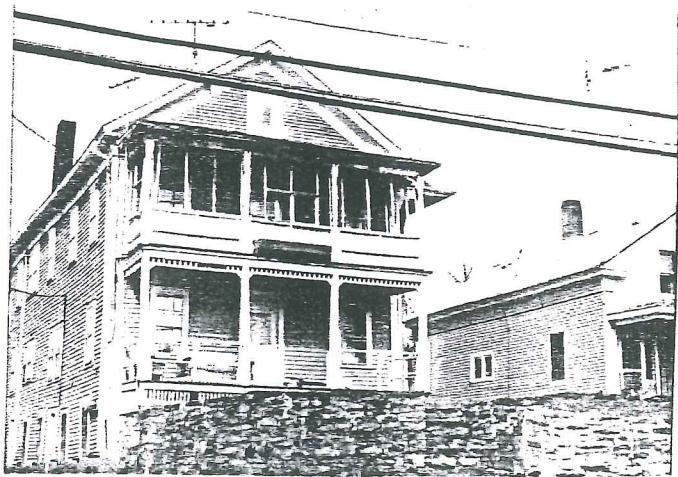
PHOTO	PHOTOGRAPHER Mark McDonough		DATE 1986
	VIEW W	NEGATIVE ON FILE A32	
COMPILED BY	NAME Mark McDonough		DATE 1986
	ORGANIZATION Town of Thompson, Connecticut		
	ADDRESS

Three-bay facade, central entry. Wood door has single large light over panels. Sash generally 6-over-6. Two-story full-width porch: turned posts, jigsaw brackets, modern two-by-four railings. First floor has stick work frieze.

Two-story corner pilasters have round-arched panels. Molded cornice on jigsaw brackets (paired on side elevation) shows partial return. Side elevations relatively plain.
