**HISTORIC RESOURCES INVENTORY**  
**BUILDING AND STRUCTURES**

IDENTIFICATION	1. BUILDING NAME (Common) <b>SWEDE VILLAGE MILL HOUSING</b> (Historic) <b>NORTH GROSVENORDALE MILL HOUSING - TYPE A</b>	
	2. TOWN CITY <b>THOMPSON</b>	VILLAGE <b>NORTH GROSVENORDALE</b>

3. STREET AND NUMBER (and/or location) <b>4 HOLMES STREET (11 HOLMES ST.) 167-88-34</b>	
	4. OWNER(S) <b>DESROCHERS, RONALD P. &amp; DONNA M., RR#1, BOX 311, N. GROS., CT 06255</b> <input type="checkbox"/> Public <input checked="" type="checkbox"/> Private

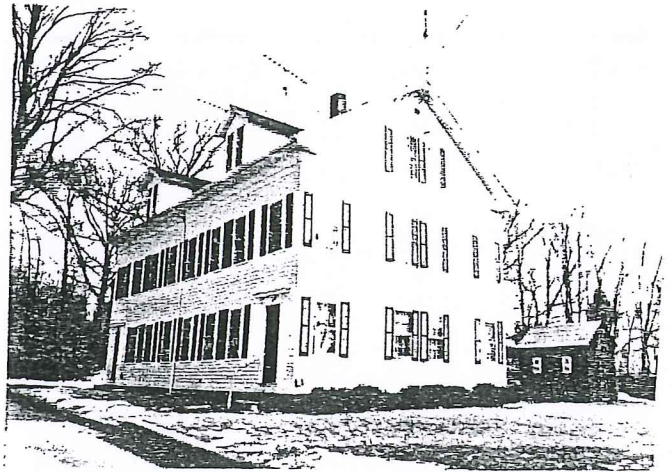
11. NUMBER OF STORIES <b>2 1/2</b> APPROXIMATE DIMENSIONS <b>50' x 30'</b>		
12. CONDITION (Structural) <input type="checkbox"/> Excellent <input checked="" type="checkbox"/> Good <input type="checkbox"/> Fair <input type="checkbox"/> Deteriorated (Exterior) <input type="checkbox"/> Excellent <input type="checkbox"/> Good <input checked="" type="checkbox"/> Fair <input type="checkbox"/> Deteriorated

Eight-bay facade with entries in first and eighth bays. Sash generally 6-over-6. Flat molded entry hoods on small jigsaw brackets. Molded window surrounds. Plain corner pilasters. Molded cornice shows partial return.

Two gabled roof dormers with paired 4-over-4 sash. Side elevations have 12 6-over-6 windows. Rear elevations virtually identical to facade. Most common alterations include later siding, later or missing entry hoods, later sash, blocked-up windows.
