HISTORIC RESOURCES INVENTORY
BUILDING AND STRUCTURES
 HIST-6 NEW 5/77

IDENTIFICATION	1. BUILDING NAME (Common) (Historic)		DIANE PARIDIS TENEMENT	
	2. TOWN CITY	VILLAGE	COUNTY	
	THOMPSON	NORTH GROSVENORDALE	WINDHAM	
	3. STREET AND NUMBER (and/or location)			
	114 MAIN STREET (61 MAIN ST.)

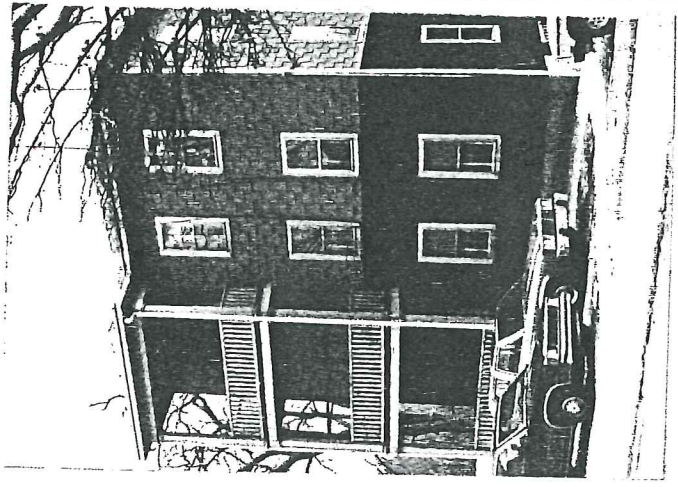
11. NUMBER OF STORIES		APPROXIMATE DIMENSIONS		
3		28' x 40'		
12. CONDITION (Structural) (Exterior)				
<input type="checkbox"/> Excellent	<input checked="" type="checkbox"/> Good	<input type="checkbox"/> Fair	<input type="checkbox"/> Deteriorated	<input type="checkbox"/> Excellent <input checked="" type="checkbox"/> Good <input type="checkbox"/> Fair <input type="checkbox"/> Deteriorated

13. INTEGRITY (Location)		WHEN ?	(Alterations)	IF YES, EXPLAIN
<input checked="" type="checkbox"/> On original site	<input type="checkbox"/> Moved		<input checked="" type="checkbox"/> Yes <input type="checkbox"/> No	later siding, storm sash

PHOTO	PHOTOGRAPHER Mark McDonough		DATE 1986
	VIEW NE	NEGATIVE ON FILE P11	
COMPILED BY	NAME Mark McDonough		DATE 1986
	ORGANIZATION Town of Thompson, Connecticut		
	ADDRESS

Three-bay facade with single-bay three-story porch sheltering entries in recessed first bay. Wooden doors have single large light over panels. Porch detail: sq. posts (suggesting Tuscan order), sq. rail and balusters. Sash generally 2-over-2. Raised concrete-over-fieldstone foundation, patterned to resemble ashlar masonry. Right elevation has four-story (downslope) porch with similar detailing at rear.
