HISTORIC RESOURCES INVENTORY
BUILDING AND STRUCTURES
 HIST-6 NEW 5/77

STATE OF CONNECTICUT
CONNECTICUT HISTORICAL COMMISSION
 59 SOUTH PROSPECT STREET, HARTFORD, CONNECTICUT 06106
 (203) 566-3005

IDENTIFICATION	1. BUILDING NAME (Common) _____ (Historic) _____	
	2. TOWN CITY THOMPSON	VILLAGE NORTH GROSVENORDALE
	3. STREET AND NUMBER (and/or location) 178 MAIN STREET & RED BRIDGE ROAD (30 MAIN ST.) 169/94-1

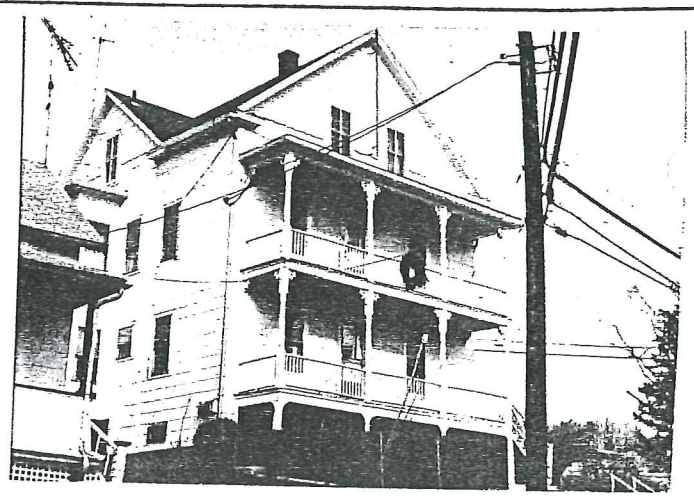
PHOTO	PHOTOGRAPHER Mark McDonough		DATE 1986
	VIEW NW	NEGATIVE ON FILE A12	
COMPILED BY	NAME Mark McDonough		DATE 1986
	ORGANIZATION Town of Thompson, Connecticut		
	ADDRESS

11. NUMBER OF STORIES 2 1/2	
	APPROXIMATE DIMENSIONS 28' x 38'	
	12. CONDITION (Structural) _____ (Exterior) _____ <input type="checkbox"/> Excellent <input checked="" type="checkbox"/> Good <input type="checkbox"/> Fair <input type="checkbox"/> Deteriorated <input type="checkbox"/> Excellent <input checked="" type="checkbox"/> Good <input type="checkbox"/> Fair <input type="checkbox"/> Deteriorated

13. INTEGRITY (Location) _____ WHEN? _____ (Alterations) _____ IF YES, EXPLAIN _____ <input checked="" type="checkbox"/> On original site <input type="checkbox"/> Moved <input checked="" type="checkbox"/> Yes <input type="checkbox"/> No new siding, storm sash.

Three-bay facade, central entry. Sash generally 2-over-2. Two-story flat-roofed porch has turned posts, molded rail, square balusters, and elaborate quarter-circular post brackets with spokes and bosses. Molded cornice, partial return. Side elevations have gabled dormers with staggered-butt shingles echoes in 20th-century siding. Left also has two-story flat-roofed bay window.
