HISTORIC RESOURCES INVENTORY
BUILDING AND STRUCTURES
 HIST-6 NEW 5/77

IDENTIFICATION	1. BUILDING NAME (Common) _____ (Historic) _____	
	2. TOWN CITY THOMPSON	VILLAGE FABYAN
	3. STREET AND NUMBER (and/or location) 219 FABYAN-WOODSTOCK ROAD (572 FABYAN RD.) 17/81-47

6. ACCESSIBILITY TO PUBLIC: <input checked="" type="checkbox"/> Yes <input type="checkbox"/> No EXTERIOR VISIBLE FROM PUBLIC ROAD <input type="checkbox"/> Yes <input checked="" type="checkbox"/> No INTERIOR ACCESSIBLE <input type="checkbox"/> Yes <input checked="" type="checkbox"/> No IF YES, EXPLAIN _____	
DESCRIPTION	7. STYLE OF BUILDING MILL HOUSING	
	DATE OF CONSTRUCTION c. 1830

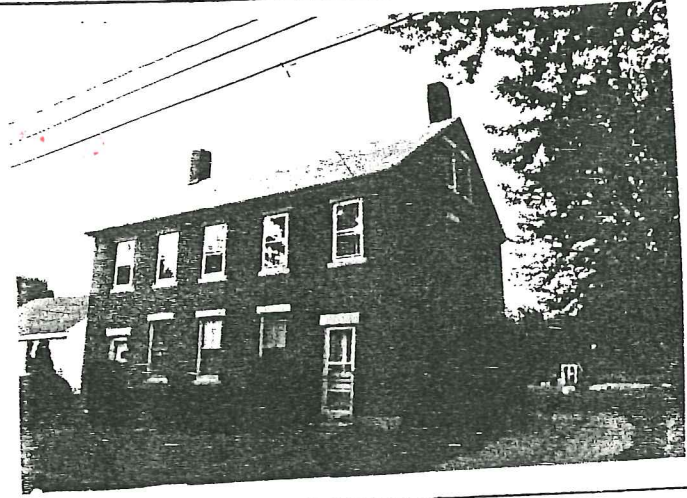
PHOTOGRAPHER Mark McDonough		DATE 1986
VIEW SW	NEGATIVE ON FILE M4	
NAME Mark McDonough		DATE 1986
ORGANIZATION Town of Thompson, Connecticut		
ADDRESS		
SUBSEQUENT FIELD EVALUATION

11. NUMBER OF STORIES APPROXIMATE DIMENSIONS		
2 1/2	40' x 30'	
12. CONDITION (Structural) _____ (Exterior) _____		
<input type="checkbox"/> Excellent <input checked="" type="checkbox"/> Good <input type="checkbox"/> Fair <input type="checkbox"/> Deteriorated	<input type="checkbox"/> Excellent <input checked="" type="checkbox"/> Good <input type="checkbox"/> Fair <input type="checkbox"/> Deteriorated

13. INTEGRITY (Location) _____ WHEN? _____ (Alterations) _____ IF YES, EXPLAIN _____		
<input checked="" type="checkbox"/> On original site <input type="checkbox"/> Moved	<input checked="" type="checkbox"/> Yes <input type="checkbox"/> No Later 19th century sash

Five-bay facade with left and right entries. Sash generally 2-over-2; granite sills and lintels. Brick walls laid up in common bond with headers every eight courses; occasional wall anchors.

Right entry retains 19th century door: twin lights with molded surrounds over panels. Molded cornice shows partial return.

Brick chimneys left and right. Both side elevations have one second floor window bricked up (a very old modification).
