**HISTORIC RESOURCES INVENTORY**  
**BUILDING AND STRUCTURES**  
 HIST-6 NEW 5/77

IDENTIFICATION	1. BUILDING NAME (Common) <span style="float: right;">(Historic)</span>		ALBERT FRISSELL HOUSE	
	2. TOWN CITY	VILLAGE	COUNTY	
	THOMPSON		WINDHAM

3. STREET AND NUMBER (and/or location)		21/105-5	
	249 HAGSTROM ROAD (125 HAGSTROM RD.)			
	4. OWNER(S)		<input type="checkbox"/> Public	<input checked="" type="checkbox"/> Private
	MACGREGOR, FRANKLIN H., HAGSTROM ROAD, WOODSTOCK, CT

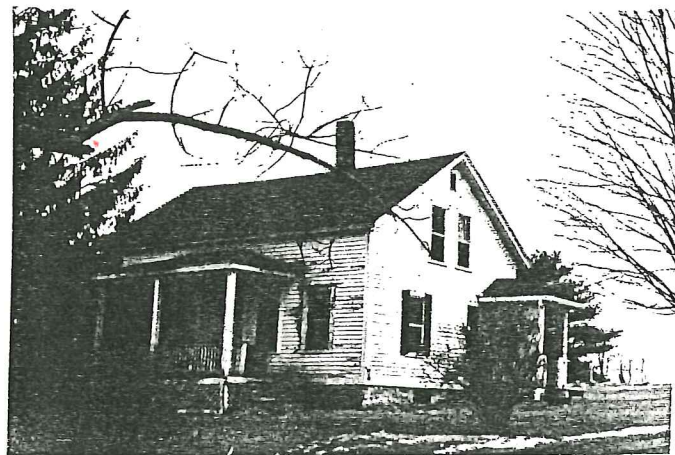
PHOTO	PHOTOGRAPHER Mark McDonough		DATE 1986
	VIEW SE	NEGATIVE ON FILE K28	
COMPILED BY	NAME Mark McDonough		DATE 1986
	ORGANIZATION Town of Thompson, Connecticut		
	ADDRESS

11. NUMBER OF STORIES		APPROXIMATE DIMENSIONS		
1 1/2		30' x 26'		
12. CONDITION (Structural)		(Exterior)		
<input type="checkbox"/> Excellent	<input checked="" type="checkbox"/> Good	<input type="checkbox"/> Fair	<input type="checkbox"/> Deteriorated	
<input type="checkbox"/> Excellent	<input checked="" type="checkbox"/> Good	<input type="checkbox"/> Fair	<input type="checkbox"/> Deteriorated

13. INTEGRITY (Location)		WHEN ?	(Alterations) IF YES, EXPLAIN	
<input checked="" type="checkbox"/> On original site	<input type="checkbox"/> Moved		<input checked="" type="checkbox"/> Yes <input type="checkbox"/> No Later porch, sash

Five-bay facade, central entry. Wood door c. 1920 with three vertically oriented panes. Sash generally five vertical panes over one. Three-bay porch with square posts and balusters, molded rail. Plain corner boards and frieze. Right rear entry sheltered by c. 1890 porch on turned posts.
