STATE OF CONNECTICUT
CONNECTICUT HISTORICAL COMMISSION
 59 SOUTH PROSPECT STREET, HARTFORD, CONNECTICUT 06106
 (203) 566-3005

| IDENTIFICATION | 1. BUILDING NAME (Common) (Historic) | | WILLIAM E. WHEELOCK HOUSE | |

STATE OF CONNECTICUT
 CONNECTICUT HISTORICAL COMMISSION
 59 South Prospect Street, Hartford, Connecticut 06106
 HISTORIC RESOURCES INVENTORY FORM
 For Buildings and Structures

CONTINUATION SHEET #17 WILLIAM E. WHEELOCK HOUSE
 Item number: _____ Date: _____

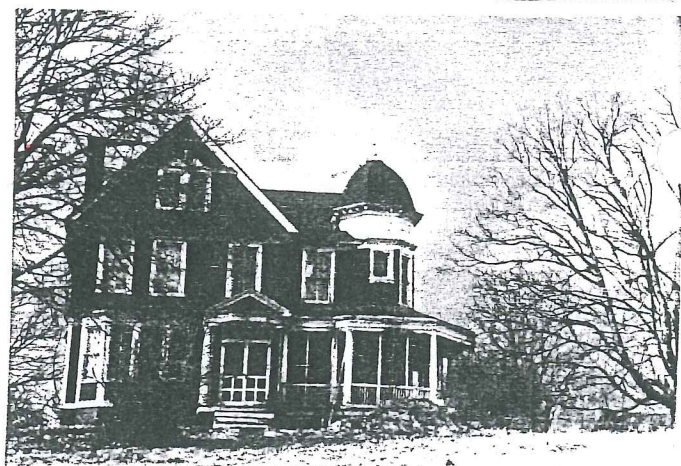
| | VIEW W | NEGATIVE ON FILE H16 | |

17 OTHER NOTABLE FEATURES OF BUILDING OR SITE (interior and/or exterior)
 Left front gable, slightly lower recessed right cross-gabled wing. Two-and-one-half-story tower at right front corner. Sash: second floor generally 8-over-2, paired 6-over-2, attic sash, some 2-over-2 and border pane stained glass.
 Gable: three bays over two. First floor has bay window left, entry right. Entry has double wood doors with large lights over panels. Above attic windows, applied decoration in the form of broken scrolled pediment. Molded cornice shows full return across gable ends; slight overhang at attic story on jigsaw brackets.
 Tuscan columned porch begins at left bay, wraps across right elevation, has peak centered over entry. Porch and bay window have molded frieze and cornice. Square balusters and rail.
 Octagonal tower has tall 2-over-2 sash on first floor, 2-over-1 on second are flanked by border pane stained glass windows. All tower windows receive keyblocks, border pane

windows also have scroll-cut sills. On attic story, very wide frieze with rectangular arrays of square panels, molded cornice on small brackets, bell shaped octagonal roof with wood finial.

Right elevation: side entry, double-hung border pane stained glass window just to left. Left elevation: side gable projects at second and attic levels on large consoles. Elliptical attic window with molded keyblock surround.
