HISTORIC RESOURCES INVENTORY
BUILDING AND STRUCTURES
 HIST-6 NEW 5/77

IDENTIFICATION	1. BUILDING NAME (Common) _____ (Historic) _____	
	2. TOWN-CITY THOMPSON	VILLAGE NORTH GROSVENORDALE
	3. STREET AND NUMBER (and/or location) 707 RAVENELLE ROAD (356 RAVENELLE RD.) 46/104-89C

7. STYLE OF BUILDING Colonial Revival	
	8. MATERIAL(S) (Indicate use or location when appropriate)	
	9. STRUCTURAL SYSTEM	
	10. ROOF (Type)	
DESCRIPTION	11. NUMBER OF STORIES: 1 1/2 APPROXIMATE DIMENSIONS: 30' x 34'

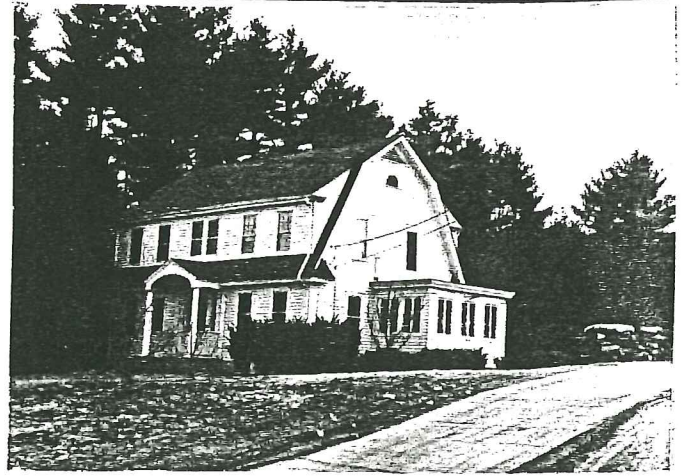
PHOTO	PHOTOGRAPHER Mark McDonough		DATE 1986
	VIEW SW	NEGATIVE ON FILE K19	
COMPILED BY	NAME Mark McDonough		DATE 1986
	ORGANIZATION Town of Thompson, Connecticut		
	ADDRESS

Five-bay facade, central entry. Sash generally 6-over-1. Wood door has single large light over panels. Sidelights, border-pane storm door. Entry has wide fluted surround; square corner blocks with turned circular bosses. Open pediment portico on Tuscan columns, molded rail, square balusters.

Above, attic story is treated as full width shed dormer; decorative cornice applied to form gambrel roof profile. Side elevations have radial glazed semi-circular attic windows; right has added or altered framed-in one story porch.

Colonial Revival architecture, most popular from about 1900 to 1930, was loosely based on the classically based formal architecture of the 18th century. In this relatively modest home, detailing is confined mainly to the sidelighted entry, the open pediment portico, and the radial-glazed attic windows. The decorate "gambrel" cornice is a relatively common feature in Colonial Revival houses; it is intended to recall the dwellings of early Dutch settlers.
