**HISTORIC RESOURCES INVENTORY**  
**BUILDING AND STRUCTURES**  
 HIST-6 NEW 5/77

IDENTIFICATION	1. BUILDING NAME (Common) <span style="float: right;">(Historic)</span>		AMEDEE & JOSEPHINE SENEY HOUSE		
	2. TOWN CITY	VILLAGE	COUNTY		
	THOMPSON	NORTH GROSVENORDALE	WINDHAM

3. STREET AND NUMBER (and/or location)			61/59 & 62-15	
	116 BUCKLEY HILL ROAD (56 BUCKLEY Hill Rd.)				
	4. OWNER(S)				
	GATINEAU, MARK A. & CYNTHIA A., BOX 755, N. GROSVENORDALE, CT 06255 <input type="checkbox"/> Public <input checked="" type="checkbox"/> Private

7. STYLE OF BUILDING				DATE OF CONSTRUCTION	
Victorian Vernacular				c. 1895	
8. MATERIAL(S) (Indicate use or location when appropriate)					
<input checked="" type="checkbox"/> Clapboard <input type="checkbox"/> Asbestos Siding <input checked="" type="checkbox"/> Chimney Brick <input type="checkbox"/> Other (Specify)					
<input checked="" type="checkbox"/> Wood Shingle <input type="checkbox"/> Asphalt Siding <input type="checkbox"/> Fieldstone					
<input type="checkbox"/> Board & Batten <input checked="" type="checkbox"/> Stucco Foundation <input type="checkbox"/> Cobblestone					
<input type="checkbox"/> Aluminum Siding <input type="checkbox"/>

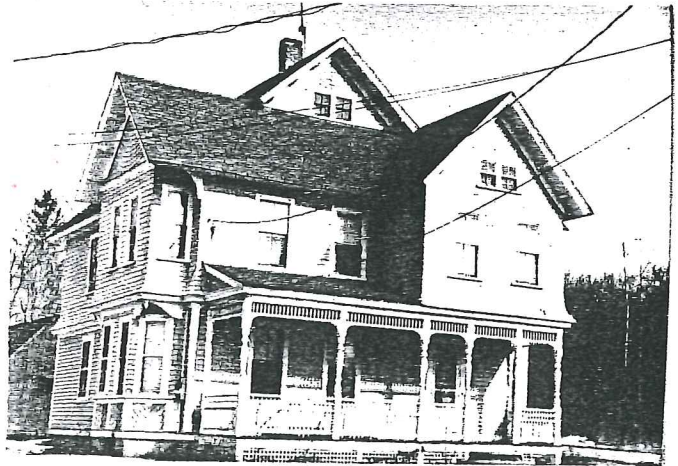
PHOTO	PHOTOGRAPHER Mark McDonough		DATE 1986
	VIEW NE	NEGATIVE ON FILE D23	
COMPILED BY	NAME Mark McDonough		DATE 1986
	ORGANIZATION Town of Thompson, Connecticut		
	ADDRESS

Three-bay facade with right entry; projecting cross-gabled oriel bay with paired windows over entry. Sash generally 2-over-2. First floor generally in clapboards, second clad with staggered-butt wood shingles.

Full width one story shed-roofed porch has turned posts with square chamfered bases, small jigsawn brackets, spindled frieze, square balusters, molded rail. Overhanging eaves on large decorative purlins. Peaks have radially arrayed shingles. Right elevation has two story gabled bay in front; all staggered-butt shingles with diagonal board panels beneath first floor windows.

Shed-roofed porch to rear is similar to front. Left elevation: similar bay, beveled first floor corners are squared by large consoles with carved sunburst designs, turned pendants.
