HISTORIC RESOURCES INVENTORY
BUILDING AND STRUCTURES
 HIST-6 NEW 5/77

PHOTO	PHOTOGRAPHER Mark McDonough	DATE 1986
	VIEW NW	NEGATIVE ON FILE F20
COMPILED BY	NAME Mark McDonough	DATE 1986
	ORGANIZATION Town of Thompson, Connecticut	
	ADDRESS

CONTINUATION SHEET KENNEY STORE

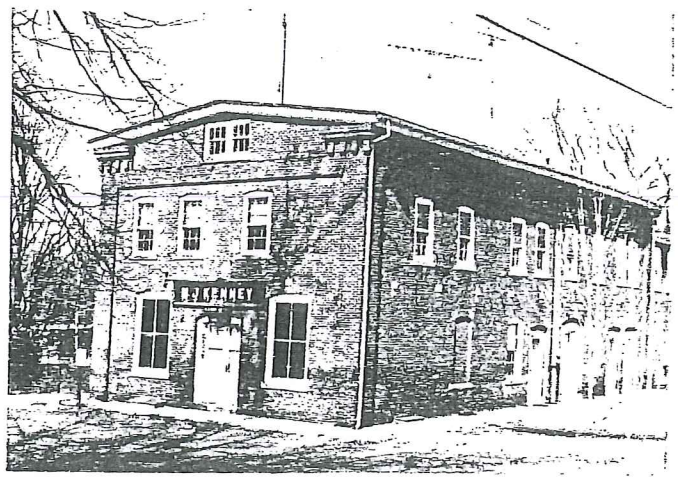
Three-bay facade, central entry with large double paneled wood doors. Window and entry openings segmental-arched. Sash oversized 2-over-2 on first floor, else generally 6-over-6. Brick walls laid up in common bond with Flemish varying granite sills, wall anchors. Brick corner pilasters and frieze, corbelled-out brick consoles, molded cornice, corbeled brick cornice, partial return (molded wood cornice under rakes).

Paired 3-over-3 attic windows. Left elevation has two side entries, right has four; both side elevations are relatively plain.

Architecturally, it is significant as a good example of late 19th-century masonry construction. The cornice detailing, wall anchors, segmental-arched door and window openings, granite sills, and the nearly flat roof are all typical of much late 19th-
