**HISTORIC RESOURCES INVENTORY  
BUILDING AND STRUCTURES**

IDENTIFICATION	1. BUILDING NAME (Common) <span style="float: right;">(Historic)</span> WHITNEY HOUSE	
	2. TOWN CITY THOMPSON	VILLAGE COUNTY WINDHAM
	3. STREET AND NUMBER (and/or location) 308 HAGSTROM ROAD (216 HAGSTROM RD.) 7/85-6B

7. STYLE OF BUILDING Greek Revival DATE OF CONSTRUCTION c. 1850	
	8. MATERIAL(S) (Indicate use or location when appropriate) <input checked="" type="checkbox"/> Clapboard <input type="checkbox"/> Asbestos Siding <input checked="" type="checkbox"/> Chimneys <input type="checkbox"/> Other (Specify) _____ <input type="checkbox"/> Wood Shingle <input type="checkbox"/> Asphalt Siding <input type="checkbox"/> Brick <input type="checkbox"/> Fieldstone <input type="checkbox"/> Board & Batten <input type="checkbox"/> Stucco <input type="checkbox"/> Cobblestone <input type="checkbox"/> Aluminum Siding <input type="checkbox"/> Concrete Type: _____ <input type="checkbox"/> Cut stone Type: _____

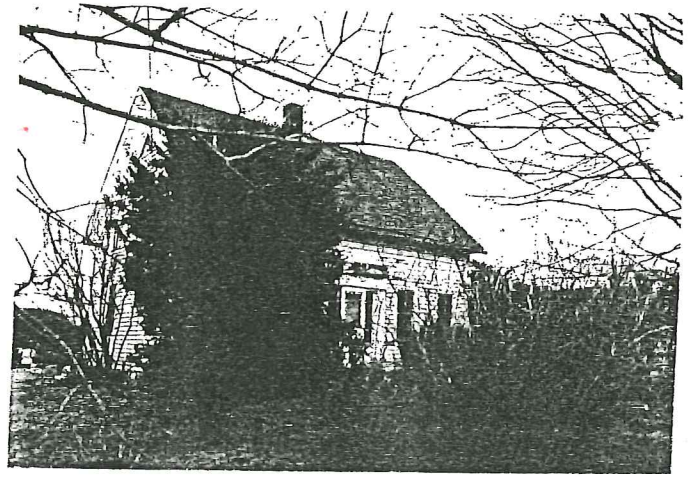
PHOTO	PHOTOGRAPHER Mark McDonough		DATE 1986
	VIEW NW	NEGATIVE ON FILE K31	
COMPILED BY	NAME Mark McDonough		DATE 1986
	ORGANIZATION Town of Thompson, Connecticut		
	ADDRESS

Five-bay facade, central entry with heavy paneled wood door. Entry surround of wide plain boards, sidelights. Sash generally 2-over-2. Wide plain corner pilasters, plain frieze; molded cornice shows partial return. Triangular attic windows. Lower parallel right rear wing.

It is architecturally significant as a good vernacular adaptation of the Greek Revival style, most popular between 1835 and 1860. The Whitney House's corner pilasters and trabeated entry were meant to suggest the columns and heavy masonry construction of a classical Greek temple. The diamond shaped windows are an unusual feature; like the simple plain pilasters and plain board entry, they are in keeping with the house's origins in a relatively isolated rural location. The ridge-parallel-to-street orientation is typical of Greek Revival houses in northeastern Connecticut.
