HISTORIC RESOURCES INVENTORY
BUILDING AND STRUCTURES
 HIST-6 NEW 5:77

IDENTIFICATION	1. BUILDING NAME (Common) (Historic)		JOHN D. CONVIS FARM	
	2. TOWN CITY		VILLAGE	COUNTY
	THOMPSON		THOMPSON	WINDHAM
	3. STREET AND NUMBER (and/or location)			
	204 ROBBINS ROAD		(129 ROBBINS RD.)

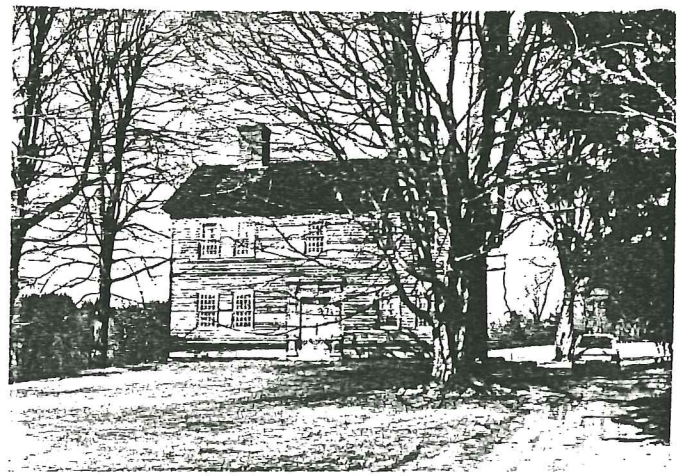
PHOTO	PHOTOGRAPHER Mark McDonough		DATE 1986
	VIEW N	NEGATIVE ON FILE K4	
COMPILED BY	NAME Mark McDonough		DATE 1986
	ORGANIZATION Town of Thompson, Connecticut		
	ADDRESS

11. NUMBER OF STORIES		APPROXIMATE DIMENSIONS		
2 1/2		38' x 28'		
12. CONDITION (Structural) (Historic)				
<input type="checkbox"/> Excellent	<input checked="" type="checkbox"/> Good	<input type="checkbox"/> Fair	<input type="checkbox"/> Deteriorated	
<input checked="" type="checkbox"/> Excellent	<input type="checkbox"/> Good	<input type="checkbox"/> Fair	<input type="checkbox"/> Deteriorated

13. INTEGRITY (Location)		WHEN?	(Alterations)	
<input checked="" type="checkbox"/> On original site	<input type="checkbox"/> Moved		<input checked="" type="checkbox"/> Yes <input type="checkbox"/> No	
IF YES, EXPLAIN				
New clapboard, entry, etc.

Five-bay facade, central entry. Sash generally recent 12-over-12. Beaded clapboards. Large twin brick chimneys. Entry is modern reproduction: double paneled doors with panes at top, fluted pilasters have capitals with applied plant decorations, denticular cap with central transom medallion resembling additional capital.

Molded cornice on small curved brackets shows partial return. Side elevations relatively plain.
