HISTORIC RESOURCES INVENTORY
BUILDING AND STRUCTURES
 HIST-6 NEW 5.77

1. BUILDING NAME (Common)		(Historic)	
2. TOWN CITY THOMPSON		VILLAGE THOMPSON	COUNTY WINDHAM
3. STREET AND NUMBER (and/or location) 1854 ROUTE 193 (361 THOMPSON RD.)		105/32-3

7. STYLE OF BUILDING Federal		DATE OF CONSTRUCTION c. 1815	
8. MATERIAL(S) (Indicate use or location when appropriate)			
<input checked="" type="checkbox"/> Clapboard <input type="checkbox"/> Asbestos Siding <input checked="" type="checkbox"/> Chimney <input type="checkbox"/> Other (Specify) _____ <input type="checkbox"/> Wood Shingle <input type="checkbox"/> Asphalt Siding <input type="checkbox"/> Brick (stuccoed) <input type="checkbox"/> Fieldstone <input type="checkbox"/> Board & Batten <input type="checkbox"/> Stucco <input type="checkbox"/> Cobblestone <input type="checkbox"/> Aluminum Siding <input type="checkbox"/> Concrete Type: _____ <input checked="" type="checkbox"/> Cut stone Type: Granite foundation facing

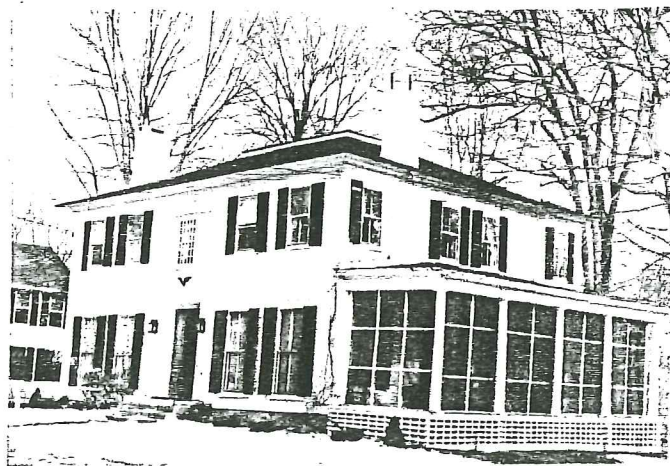
PHOTO	PHOTOGRAPHER Mark McDonough		DATE 1986
	VIEW NE	NEGATIVE ON FILE E15	
COMPILED BY:	NAME Mark McDonough		DATE 1986
	ORGANIZATION Town of Thompson, Connecticut		
	ADDRESS

DESCRIPTION (Continued)	17 OTHER NOTABLE FEATURES OF BUILDING OR SITE (interior and/or exterior)
	<p>Five-bay, central entry. Sash 2-over-2, oversized on first floor, molded window surrounds. Entry: large, recessed with paneled soffit, wide paneled surround; double doors have large rectangular lights over projecting pyramidal panels. Above entry, a simplified Palladian window: fixed 30-pane window flanked by paired paneled pilasters, semi-elliptical molding with fluted keyblock above.</p> <p>House has wooden quoins. Frieze with incised vertical lines, delicate sawtooth bed molding, molded cornice. Shallow hip roof, flattened at ridge. Right elevations has one-story screened-in Tuscan-columned porch with frieze similar to main roof. Left elevation retains some old 6-over-6 sash.</p>
