HISTORIC RESOURCES INVENTORY BUILDING AND STRUCTURES

1. BUILDING NAME (Common)		(Historic)	
		JASON PHIPPS, JR. HOUSE	
2. TOWN CITY	VILLAGE	COUNTY	
THOMPSON	THOMPSON	WINDHAM	
3. STREET AND NUMBER (and/or location)		105/34-12	
1922 ROUTE 193 (325 THOMPSON RD.)

7. STYLE OF BUILDING		DATE OF CONSTRUCTION	
Vernacular		c. 1840	
8. MATERIALS: (indicate use or location when appropriate)			
<input checked="" type="checkbox"/> Clapboard	<input type="checkbox"/> Asbestos Siding	<input checked="" type="checkbox"/> Brick	<input type="checkbox"/> Other (Specify)
<input type="checkbox"/> Wood Shingle	<input type="checkbox"/> Asphalt Siding	<input checked="" type="checkbox"/> Foundation	
<input type="checkbox"/> Board & Batten	<input type="checkbox"/> Stucco	<input type="checkbox"/> Concrete	
<input type="checkbox"/> Aluminum Siding	<input type="checkbox"/> Concrete Type:	<input type="checkbox"/> Stone

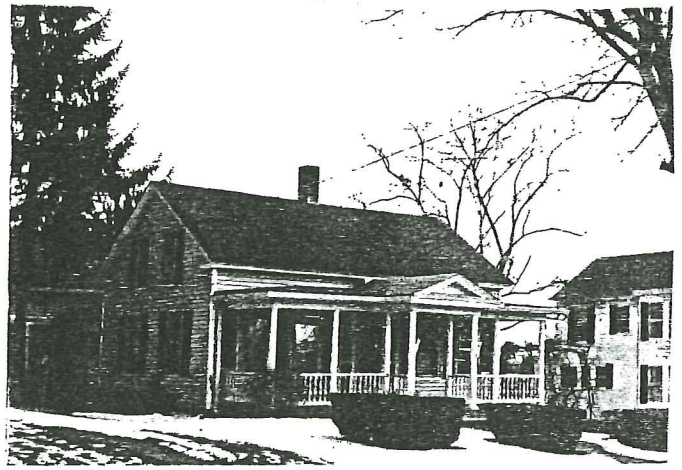
PHOTO	PHOTOGRAPHER Mark McDonough		DATE 1986
	VIEW SE	NEGATIVE ON FILE E27	
COMPILED BY	NAME Mark McDonough		DATE 1986
	ORGANIZATION Town of Thompson, Connecticut		
	ADDRESS

11. NUMBER OF STORIES		APPROXIMATE DIMENSIONS	
1 1/2		30' X 20' (main portion)	
12. CONDITION (Structural)			
<input type="checkbox"/> Excellent	<input checked="" type="checkbox"/> Good	<input type="checkbox"/> Fair	<input type="checkbox"/> Deteriorated
<input type="checkbox"/> Excellent	<input checked="" type="checkbox"/> Good	<input type="checkbox"/> Fair	<input type="checkbox"/> Deteriorated

DESCRIPTION (Continued)	17 OTHER NOTABLE FEATURES OF BUILDING OR SITE (interior and/or exterior)
	<p>Five-bay facade, central entry has paneled wood door with rectangular stained-glass sidelights. Fluted pilasters and lintel with plain corner blocks. Sash generally 2-over-2; windows have simple molded caps. One-story full-width porch has projecting pedimented peak centered on entry bay. Other porch detail: slender Tuscan columns with entasis, turned balusters, molded rail, plain frieze with top and bottom moldings, molded cornice.</p> <p>House has plain corner boards, molded cornice, partial return. To rear, short connector to large parallel rear wing.</p>
