**HISTORIC RESOURCES INVENTORY**  
**BUILDING AND STRUCTURES**  
 HIST-6 NEW 5/77

IDENTIFICATION	1. BUILDING NAME (Common) <span style="float: right;">(Historic)</span>		ERASTUS KNIGHT HOUSE (1)		
	2. TOWN CITY THOMPSON	VILLAGE THOMPSON	COUNTY WINDHAM

3. STREET AND NUMBER (and/or location) 42 ROUTE 200 (362 THOMPSON Hill Rd.)		105/40-17		
	4. OWNER(S) BIGELOW, JOHN B. & MARGARETE K., THOMPSON, CT 06277		<input type="checkbox"/> Public	<input checked="" type="checkbox"/> Private

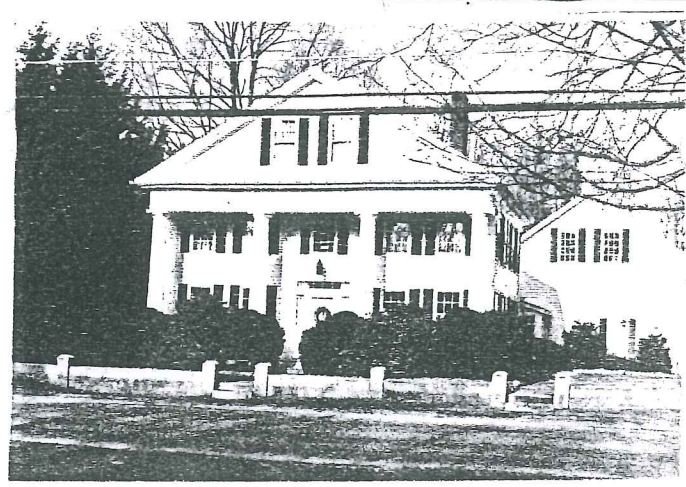
PHOTO	PHOTOGRAPHER Mark McDonough		DATE 1986
	VIEW N	NEGATIVE ON FILE G22	
COMPILED BY	NAME Mark McDonough		DATE 1986
	ORGANIZATION Town of Thompson, Connecticut		
	ADDRESS		
20 SUBSEQUENT FIELD EVALUATION:

11. NUMBER OF STORIES   APPROXIMATE DIMENSIONS					
2 1/2		38' x 37'			
12. CONDITION (Structural)   (Exterior)					
<input type="checkbox"/> Excellent	<input checked="" type="checkbox"/> Good	<input type="checkbox"/> Fair	<input type="checkbox"/> Deteriorated	<input type="checkbox"/> Excellent <input checked="" type="checkbox"/> Good <input type="checkbox"/> Fair <input type="checkbox"/> Deteriorated

Five-bay facade, central entry in oversized bay. Entry has heavy paneled wood door, modified border-pane sidelights and glazed transom. Paneled pilasters and transom bar with paneled corner blocks. Paneled lintel above with central paneled block. Pedimented peak carried forward on two story fluted Doric columns. Molded architrave, plain frieze, molded cornice. Plain corner pilasters. Sash generally old 6-over-6.

Right rear parallel wing connects to barn with square cupola. Cupola has segmental arched louvers, molded cornice, overhanging eaves on small jigsaw brackets, cross-gabled roof with flush-boarded pedimented peaks, wood finial.
