HISTORIC RESOURCES INVENTORY
BUILDING AND STRUCTURES
 HIST-6 NEW 5/77

IDENTIFICATION	1. BUILDING NAME (Common) (Historic)		CHARLES H. BALDWIN HOUSE		
	2. TOWN CITY	VILLAGE	COUNTY		
	THOMPSON	THOMPSON	WINDHAM		
	3. STREET AND NUMBER (and/or location)			107/34-6	
	136 ROUTE 21 (63 COUNTY HOME RD.)

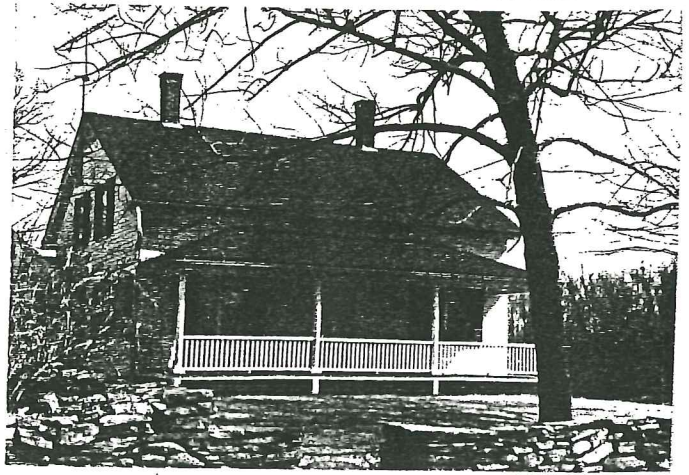
PHOTO	PHOTOGRAPHER Mark McDonough		DATE 1986
	VIEW SE	NEGATIVE ON FILE K1	
COMPILED BY	NAME Mark McDonough		DATE 1986
	ORGANIZATION Town of Thompson, Connecticut		
	ADDRESS

Three-bay facade, central entry flanked by paired 4-over-4 sash. Paneled wood door has twin round-arched windows with prominent molded surrounds.

One story full width porch on slender Tuscan columns has square balusters, molded rail. Plain corner boards and frieze; molded cornice shows partial return. Original attached shed at left rear corner.

Architecturally, the Baldwin house resembles many small vernacular houses built in Connecticut during the 19th century. The large windows of the facade, twin brick chimneys, and the round-arched door windows are all common features in houses built between 1850 and about 1880 (the specific arrangement of the sash is unusual). The porch may well be a later (c. 1900 addition).
