HISTORIC RESOURCES INVENTORY
BUILDING AND STRUCTURES
 HIST-6 NEW 5.77

1. BUILDING NAME (Common)		(Historic)	
RUSSIAN BEAR ANTIQUES			
2. TOWN CITY	VILLAGE	COUNTY	
THOMPSON	THOMPSON	WINDHAM	
3. STREET AND NUMBER (and/or location)		109/35-11A	
545 ROUTE 21 (270 COUNTY HOME RD.)			
4. OWNER(S)		<input type="checkbox"/> Public <input checked="" type="checkbox"/> Private	
Strong, Frank M. & Camille M., ROUTE 21, THOMPSON, CT 06277			
5. USE (Present)		(Historic)	
Residence/Shop		Residence	
6. ACCESSIBILITY TO PUBLIC:		IF YES, EXPLAIN.	
EXTERIOR VISIBLE FROM PUBLIC ROAD		INTERIOR ACCESSIBLE	
<input checked="" type="checkbox"/> Yes <input type="checkbox"/> No		<input type="checkbox"/> Yes <input checked="" type="checkbox"/> No

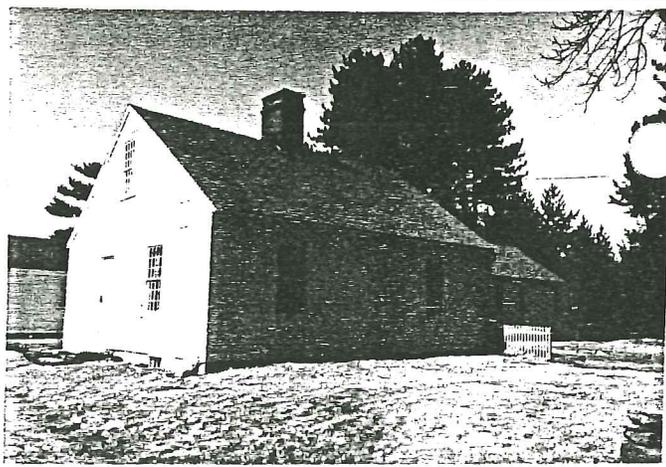
11. NUMBER OF STORIES		APPROXIMATE DIMENSIONS	
1 1/2		30' x 26'	
12. CONDITION (Structural)			
<input type="checkbox"/> Excellent	<input checked="" type="checkbox"/> Good	<input type="checkbox"/> Fair	<input type="checkbox"/> Deteriorated
<input type="checkbox"/> Excellent	<input checked="" type="checkbox"/> Good	<input type="checkbox"/> Fair	<input type="checkbox"/> Deteriorated

PHOTO	PHOTOGRAPHER Mark McDonough		DATE 1986
	VIEW NW	NEGATIVE ON FILE K2	
COMPILED BY	NAME Mark McDonough		DATE 1986
	ORGANIZATION Town of Thompson, Connecticut		
	ADDRESS

17 OTHER NOTABLE FEATURES OF BUILDING OR SITE (interior and/or exterior)
 Three-bay facade, asymmetrical spacing with entry in second bay. Sash old 12-over-12. Very simple construction. Heavy paneled wood door, plain corner boards, plain cornice. Central brick chimney. Left elevation has side entry. Rear elevation has various lower extensions. Right elevation has old parallel wing at rear corner.
