HISTORIC RESOURCES INVENTORY
BUILDING AND STRUCTURES
 HIST-6 NEW 5-77

1. BUILDING NAME (Common)	(Historic)		
	JOHN JOSLIN HOUSE		
2. TOWN CITY	VILLAGE	COUNTY	
THOMPSON	THOMPSON	WINDHAM	
3. STREET AND NUMBER (and lot or block)	APPROX. LOCATION		
81 ROUTE 193	(1356 THOMPSON Ro.) demolished 1998		114/27-28
4. OWNER(S)			
WELOCK, JOHN et al, RR#1, THOMPSON, CT 06277	<input type="checkbox"/> Public <input checked="" type="checkbox"/> Private		
5. USE (Present)	(Historic)		
Residence	Residence		
6. ACCESSIBILITY TO PUBLIC:	EXTERIOR VISIBLE FROM PUBLIC ROAD	INTERIOR ACCESSIBLE	IF YES, EXPLAIN
<input checked="" type="checkbox"/> Yes <input type="checkbox"/> No	<input type="checkbox"/> Yes <input checked="" type="checkbox"/> No

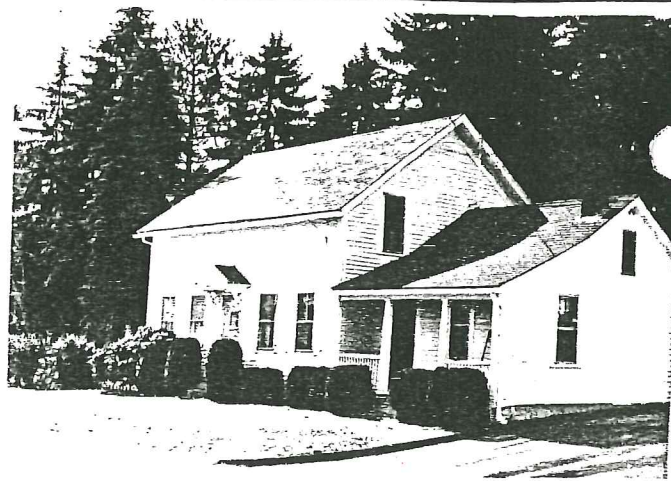
PHOTO	PHOTOGRAPHER Mark McDonough		DATE 1986
	VIEW SW	NEGATIVE ON FILE J22	
COMPILED BY	NAME Mark McDonough		DATE 1986
	ORGANIZATION Town of Thompson, Connecticut		
	ADDRESS

11. NUMBER OF STORIES	
1 1/2	
APPROXIMATE DIMENSIONS	
28' x 24'	
12. CONDITION (Structural)	
<input type="checkbox"/> Excellent <input checked="" type="checkbox"/> Good <input type="checkbox"/> Fair <input type="checkbox"/> Deteriorated	(Exterior) <input type="checkbox"/> Excellent <input checked="" type="checkbox"/> Good <input type="checkbox"/> Fair <input type="checkbox"/> Deteriorated

13. INTEGRITY (Location)	
<input checked="" type="checkbox"/> On original site	<input type="checkbox"/> Moved
<input checked="" type="checkbox"/> Yes	<input type="checkbox"/> No
	IF YES, EXPLAIN
	Later porch

17 OTHER NOTABLE FEATURES OF BUILDING OR SITE (interior and/or exterior)
 Five-bay facade, central entry. Paneled wood door has single large light. Gabled entry hood on chamfered braces. Sash generally 2-over-2. Plain corner boards and frieze, molded cornice. Right elevation has lower parallel wing, side entry. Eaves of wing flare to form porch on square tapered posts (c. 1900); porch has square balusters and molded rail.
