HISTORIC RESOURCES INVENTORY
BUILDING AND STRUCTURES

IDENTIFICATION	1. BUILDING NAME (Common) _____ (Historic) _____	
	2. TOWN CITY THOMPSON	VILLAGE THOMPSON
	3. STREET AND NUMBER (and/or location) 1230 ROUTE 193 (715 THOMPSON RO.) 120/21-2

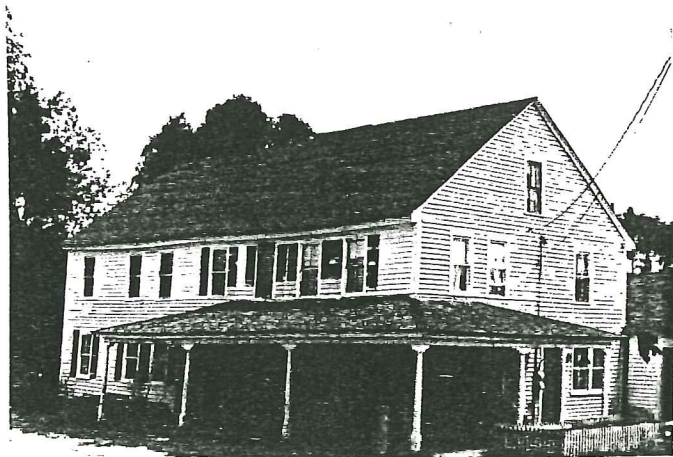
PHOTO	PHOTOGRAPHER Mark McDonough		DATE 1986
	VIEW NE	NEGATIVE ON FILE M13	
COMPILED BY	NAME Mark McDonough		DATE 1986
	ORGANIZATION Town of Thompson, Connecticut		
	ADDRESS

11. NUMBER OF STORIES 2 1/2	APPROXIMATE DIMENSIONS 51' x 29'
	12. CONDITION: Structural (Exterior)	
	<input type="checkbox"/> Excellent <input type="checkbox"/> Good <input type="checkbox"/> Fair <input checked="" type="checkbox"/> Deteriorated <input type="checkbox"/> Excellent <input type="checkbox"/> Good <input checked="" type="checkbox"/> Fair <input type="checkbox"/> Deteriorated

13. INTEGRITY: (Location) ? WHEN? (Alterations) IF YES, EXPLAIN	
	<input type="checkbox"/> On original site <input type="checkbox"/> Moved <input checked="" type="checkbox"/> Yes <input type="checkbox"/> No Chimney removed

17 OTHER NOTABLE FEATURES OF BUILDING OR SITE (interior and/or exterior)
 Building consists of two parallel wings. Left portion: three bay somewhat lower roofline. Most sash 2-over-2, some old 6-over-2. Right portion: four bays, unevenly spaced.
 Entry in first bay has paneled wood door. Right porch on tapered round columns, no rail. Both portions have molded cornice showing partial return. Right elevation has side entry.
 One story parallel outbuildings attached at right rear corner.
