HISTORIC RESOURCES INVENTORY
BUILDING AND STRUCTURES
 HIST-6 NEW 5/77

IDENTIFICATION	1. BUILDING NAME (Common) (Historic)	
	BETHANY CHRISTIAN HOMESTEAD	ALBIN AND HIRAM MUNYAN HOUSE
	2. TOWN CITY	VILLAGE
	THOMPSON	THOMPSON
	3. STREET AND NUMBER (and/or location)	
	2 TAYLOR ROAD	66 64-66 TAYLOR RD.

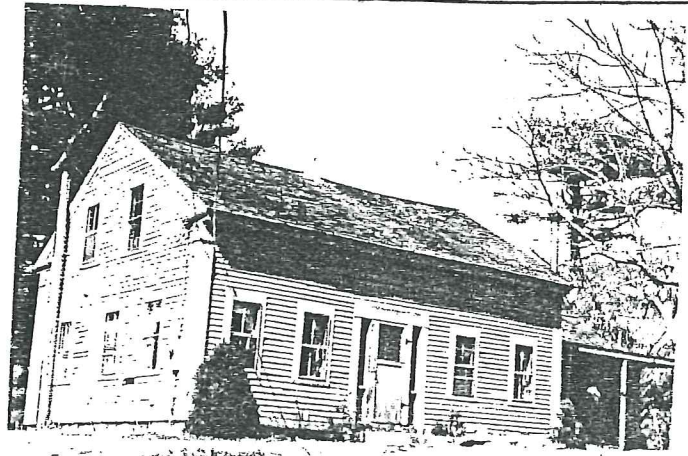
PHOTO	PHOTOGRAPHER Mark McDonough	DATE 1986
	VIEW NE	NEGATIVE ON FILE L25
COMPILED BY	NAME Mark McDonough	DATE 1986
	ORGANIZATION Town of Thompson, Connecticut	
	ADDRESS

11. NUMBER OF STORIES		
1 1/2		
APPROXIMATE DIMENSIONS		
32' x 24'		
12. CONDITION (Structural) (Exterior)		
<input type="checkbox"/> Excellent <input checked="" type="checkbox"/> Good <input type="checkbox"/> Fair <input type="checkbox"/> Deteriorated <input type="checkbox"/> Excellent <input type="checkbox"/> Good <input checked="" type="checkbox"/> Fair <input type="checkbox"/> Deteriorated

13. INTEGRITY (Location) (Alterations)		
<input checked="" type="checkbox"/> On original site <input type="checkbox"/> Moved WHEN? <input checked="" type="checkbox"/> Yes <input type="checkbox"/> No IF YES, EXPLAIN		
Later 19th century sash

Five-bay facade, central entry, sash generally 2-over-2. Old heavy paneled wood door is flanked by rectangular sidelights over panels. Wide plain-board entry surround. Wide plain corner pilasters. Molded architrave, plain frieze; molded cornice shows partial return.

Left elevation is plain. To right, lower parallel kitchen wing with open porch on recent square posts.
