HISTORIC RESOURCES INVENTORY
BUILDING AND STRUCTURES
 HIST-6 NEW 5.77

1. BUILDING NAME (Common)		(Historic)	
THOMPSON		CROSBY TAVERN	
2. TOWN CITY	VILLAGE	COUNTY	
THOMPSON	QUINEBAUG	WINDHAM	
3. STREET AND NUMBER (and/or location)		17/71A-6	
718 ROUTE 131 (441 Quinebaug) DEMOLISHED 1989			
4. OWNER(S)		<input type="checkbox"/> Public <input checked="" type="checkbox"/> Private	
BLACKMER, RANDOLPH C. JR. & MYRTIE, C., N. GROSVENORDALE, CT 06255			
5. USE (Present)		(Historic)	
Residence		Residence	
6. ACCESSIBILITY TO PUBLIC:		IF YES, EXPLAIN	
<input checked="" type="checkbox"/> Yes <input type="checkbox"/> No		<input type="checkbox"/> Yes <input checked="" type="checkbox"/> No

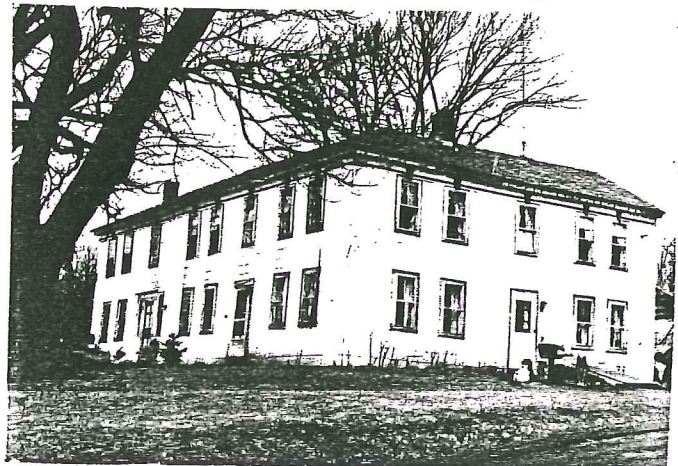
PHOTO	PHOTOGRAPHER Mark McDonough	DATE 1986
	VIEW NW	NEGATIVE ON FILE HØ
COMPILED BY	NAME Mark McDonough	DATE 1986
	ORGANIZATION Town of Thompson, Connecticut	
	ADDRESS

Eight-bay facade with uneven spacing. Entries in third and sixth bays. Entry in third bay has heavy paneled wood door with flanking 1-over-1 windows. Entry in sixth bay has small pane door. Cornice has roll molding, plain wooden keyblocks centered above all second floor windows.

Architecturally, it is much altered by modern siding and later sash. The second floor keyblocks and roll molding suggest a Federal influence.
