HISTORIC RESOURCES INVENTORY
BUILDING AND STRUCTURES
 HIST-6 NEW 5/77

IDENTIFICATION	1. BUILDING NAME (Common) _____ (Historic) _____	
	2. TOWN CITY THOMPSON	VILLAGE QUINEBAUG
	3. STREET AND NUMBER (and/or location) 74 ROUTE 197 (172 OLD TURNPIKE) 3/77-5

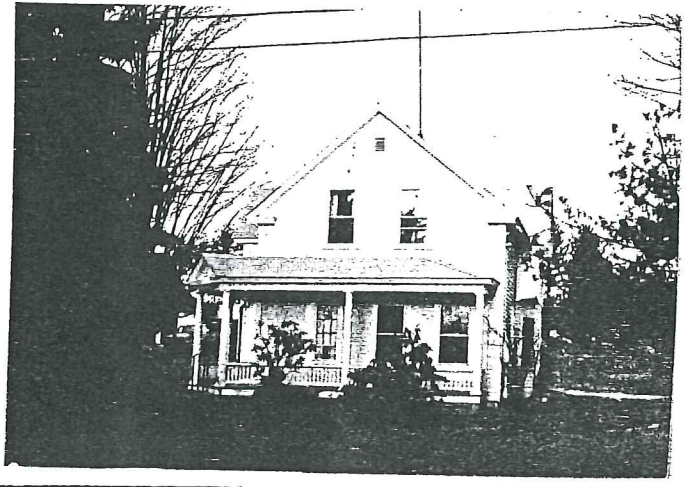
PHOTO	PHOTOGRAPHER Mark McDonough	DATE 1986
	VIEW NW	NEGATIVE ON FILE H24
COMPILED BY	NAME Mark McDonough	DATE 1986
	ORGANIZATION Town of Thompson, Connecticut	
	ADDRESS

11. NUMBER OF STORIES APPROXIMATE DIMENSIONS 1 1/2 20' x 26'	
	12. CONDITION (Structural) (Exterior) <input type="checkbox"/> Excellent <input checked="" type="checkbox"/> Good <input type="checkbox"/> Fair <input type="checkbox"/> Deteriorated <input type="checkbox"/> Excellent <input checked="" type="checkbox"/> Good <input type="checkbox"/> Fair <input type="checkbox"/> Deteriorated

13. INTEGRITY (Location) WHEN ? (Alterations) IF YES, EXPLAIN <input checked="" type="checkbox"/> On original site <input type="checkbox"/> Moved <input checked="" type="checkbox"/> Yes <input type="checkbox"/> No Later porch

Three-bay facade, left entry. All three first floor bays offset to right. Heavy paneled wood door. Sash generally 2-over-2. One story Tuscan columned porch wraps left to meet bay window, forms beveled corner with gable above concrete steps at left front. Narrow corner pilasters with molded capitals. Plain frieze; molded cornice shows partial return.

Right elevation: two story gabled bay window, beveled on first floor, squared and with corner pilasters on second. Left: one-and-one-half-story bay window, rectangular with corner pilasters. Large parallel rear wing.
