HISTORIC RESOURCES INVENTORY
BUILDING AND STRUCTURES
 HIST-6 NEW 5/77

1. BUILDING NAME (Common) (Historic)	
ST. STEPHEN'S ROMAN CATHOLIC CHURCH	ST. STEPHEN'S ROMAN CATHOLIC CHURCH
2. TOWN CITY	VILLAGE COUNTY
THOMPSON	QUINEBAUG WINDHAM

3. STREET AND NUMBER (and/or location) 130-134 164 ROUTE 197 (134 OLD TURNPIKE) 3/79-1	
4. OWNER(S) ST. STEPHEN'S ROMAN CATHOLIC CHURCH, QUINEBAUG, CT 06262 <input type="checkbox"/> Public <input checked="" type="checkbox"/> Private

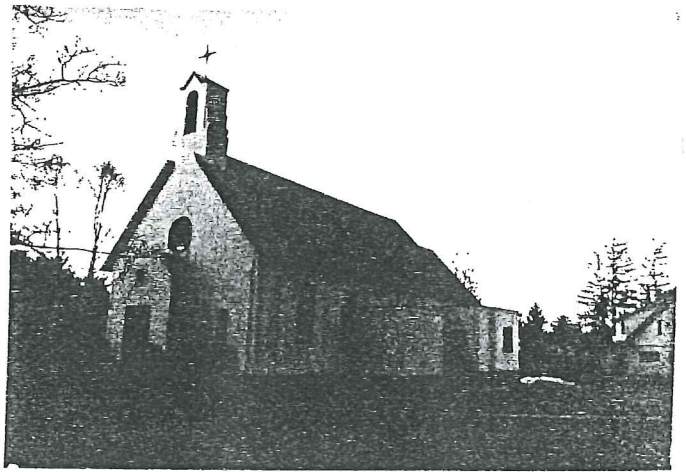
PHOTO	PHOTOGRAPHER Mark McDonough		DATE 1986
	VIEW W	NEGATIVE ON FILE H28	
COMPILED BY	NAME Mark McDonough		DATE 1986
	ORGANIZATION Town of Thompson, Connecticut		
	ADDRESS

11. NUMBER OF STORIES	APPROXIMATE DIMENSIONS
2 1/2	32' x 62'
12. CONDITION (Structural) (Exterior)	
<input type="checkbox"/> Excellent <input checked="" type="checkbox"/> Good <input type="checkbox"/> Fair <input type="checkbox"/> Deteriorated	<input type="checkbox"/> Excellent <input checked="" type="checkbox"/> Good <input type="checkbox"/> Fair <input type="checkbox"/> Deteriorated

Three-bay facade with projecting central entry pavillion with arched Mission parapet, round arched windows to left and right. Double batten doors with elaborate strap hinges, small stained glass windows with cross motif.

Above, semi-circular recessed stucco panel with raised stucco cross. Main wall area has circular stained glass window with stepped edges. Molded cornice pierced by square gabled belfry with round arched louver, stucco foot scrolls, and ornate metal cross.

Side elevations have various small added bays, stucco pilasters, rectangular stained glass windows. Rear elevation has boarded up pointed arched window.
