HISTORIC RESOURCES INVENTORY BUILDING AND STRUCTURES

1. BUILDING NAME (Common) VFW HALL		(Historic) NEW BOSTON SCHOOL	
2. TOWN CITY THOMPSON		VILLAGE QUINEBAUG	COUNTY WINDHAM
3. STREET AND NUMBER (and/or location) 285 ROUTE 131 (654 QUINEBAUG RD.)		3/81-38

#19 NEW BOSTON SCHOOL

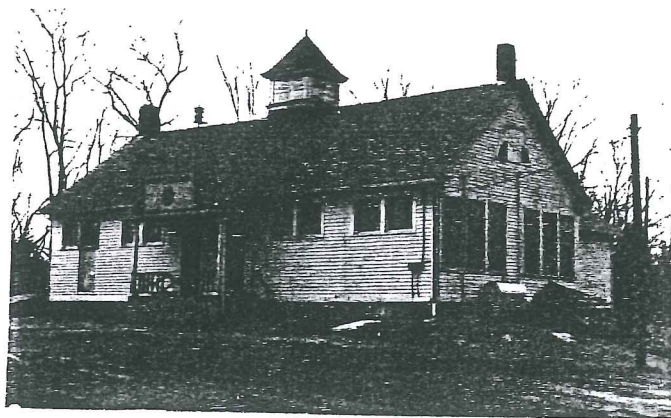
PHOTO	PHOTOGRAPHER Mark McDonough		DATE 1986
	VIEW SE	NEGATIVE ON FILE H19	
COMPILED BY	NAME Mark McDonough		DATE 1986
	ORGANIZATION Town of Thompson, Connecticut		
	ADDRESS

11. NUMBER OF STORIES 1 1/2		APPROXIMATE DIMENSIONS 60' x 30'	
12. CONDITION (Structural)			
<input type="checkbox"/> Excellent <input type="checkbox"/> Good <input checked="" type="checkbox"/> Fair <input type="checkbox"/> Deteriorated		(Exterior) <input type="checkbox"/> Excellent <input type="checkbox"/> Good <input checked="" type="checkbox"/> Fair <input type="checkbox"/> Deteriorated

DESCRIPTION (Continued)	17 OTHER NOTABLE FEATURES OF BUILDING OR SITE (interior and/or exterior)
	<p>Six-bay facade, paired six pane windows, entries in third and fourth bays under gabled portico on Tuscan columns. Doors have single large lights over panels, three pane glazed transom. Plain corner boards, molded cornice, partial return.</p> <p>Left elevation has side entry with recent wood door, two large window arrays, boarded-up. Two quarter-circle attic windows flank a square panel with carved sunburst. Right elevation similar, but window array exposed with triple oversized 2-over-2 sash. Square cupola with matched boards, plain corner boards, pyramidal roof. Plain cross-gabled rear wing.</p>
