HISTORIC RESOURCES INVENTORY
BUILDING AND STRUCTURES
 HIST-6 NEW 5/77

IDENTIFICATION	1. BUILDING NAME (Common) (Historic)		JESSIE F. CONVERSE HOUSE	
	2. TOWN CITY THOMPSON	VILLAGE WILSONVILLE	COUNTY WINDHAM	
	3. STREET AND NUMBER (and/or location) 748 WILSONVILLE ROAD <i>(122 WILSONVILLE Rd.)</i>		77/46-1A

7. STYLE OF BUILDING Greek Revival		DATE OF CONSTRUCTION c. 1855	
	8. MATERIAL(S) (Indicate use or location when appropriate)			
	<input checked="" type="checkbox"/> Clapboard <input type="checkbox"/> Asbestos Siding <input checked="" type="checkbox"/> Chimney <input type="checkbox"/> Brick <input type="checkbox"/> Other (Specify) _____ <input type="checkbox"/> Wood Shingle <input type="checkbox"/> Asphalt Siding <input checked="" type="checkbox"/> Fieldstone Foundation (granite facing) <input type="checkbox"/> Board & Batten <input type="checkbox"/> Stucco <input type="checkbox"/> Cobblestone <input type="checkbox"/> Aluminum Siding <input type="checkbox"/> Concrete Type: _____ <input type="checkbox"/> Cut stone Type: _____

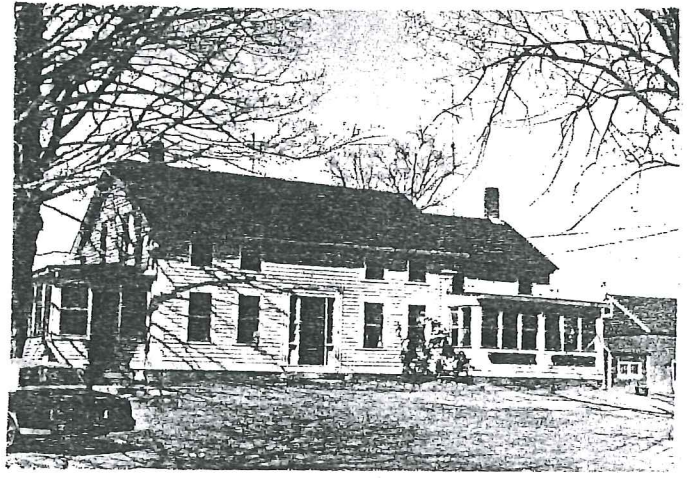
PHOTO	PHOTOGRAPHER	DATE
	Mark McDonough	1986
COMPILED BY	VIEW	NEGATIVE ON FILE
	NE	L31
	NAME	DATE
	Mark McDonough	1986
	ORGANIZATION	
	Town of Thompson, Connecticut	
	ADDRESS

11. NUMBER OF STORIES 1 1/2		APPROXIMATE DIMENSIONS 34' x 24' (main part)	
	12. CONDITION (Structural) (Exterior)			
	<input type="checkbox"/> Excellent <input checked="" type="checkbox"/> Good <input type="checkbox"/> Fair <input type="checkbox"/> Deteriorated <input type="checkbox"/> Excellent <input checked="" type="checkbox"/> Good <input type="checkbox"/> Fair <input type="checkbox"/> Deteriorated

13. INTEGRITY (Location)		WHEN ?	(Alterations) IF YES, EXPLAIN
	<input checked="" type="checkbox"/> On original site <input type="checkbox"/> Moved		<input checked="" type="checkbox"/> Yes <input type="checkbox"/> No	Modern storm sash, porches

Five-bay facade; central entry. Sash 6-over-6 on first, small 3-over-3 frieze band windows. Entry has paneled pilasters, sidelights, paneled lintel and corner blocks. Old heavy paneled wood door. Wide corner pilasters with molded caps.

Wide plain frieze, molded cornice shows partial return. Single chimney offset left. Right elevation has lower one-and-one-half-story parallel wing with added glassed-in porch. Left elevation: later framed-in porch.
