HISTORIC RESOURCES INVENTORY
BUILDING AND STRUCTURES
 HIST-6 NEW 5/77

1. BUILDING NAME (Common)		(Historic)	
THOMPSON		GEORGE P. NICHOLS FARM	
2. TOWN CITY	VILLAGE	COUNTY	
THOMPSON	THOMPSON	WINDHAM	
3. STREET AND NUMBER (and/or location)			
2461 ROUTE 193		(42 THOMPSON RD.)	
4. OWNER(S)		87/38-17B	
DAVIS, BERNARD, BOX 8A, THOMPSON, CT 06277		<input type="checkbox"/> Public	<input checked="" type="checkbox"/> Private
5. USE (Present)		(Historic)	
Residence		Residence	
6. ACCESSIBILITY TO PUBLIC:			
EXTERIOR VISIBLE FROM PUBLIC ROAD		INTERIOR ACCESSIBLE	
<input checked="" type="checkbox"/> Yes <input type="checkbox"/> No		<input type="checkbox"/> Yes <input checked="" type="checkbox"/> No	
IF YES, EXPLAIN

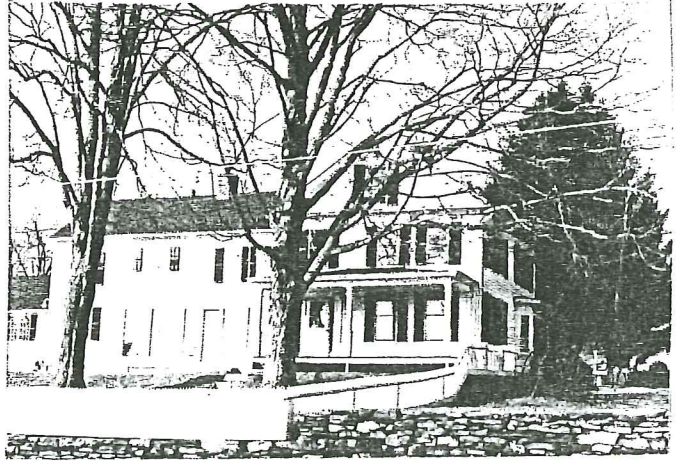
PHOTO	PHOTOGRAPHER Mark McDonough		DATE 1986
	VIEW W	NEGATIVE ON FILE G6	
COMPILED BY	NAME Mark McDonough		DATE 1986
	ORGANIZATION Town of Thompson, Connecticut		
	ADDRESS

11. NUMBER OF STORIES		APPROXIMATE DIMENSIONS	
2 1/2		25' X 30' (main); 40' X 20' (ell)	
12. CONDITION (Structural)			
<input type="checkbox"/> Excellent	<input checked="" type="checkbox"/> Good	<input type="checkbox"/> Fair	<input type="checkbox"/> Deteriorated
(Exterior)		<input type="checkbox"/> Excellent	<input checked="" type="checkbox"/> Good <input type="checkbox"/> Fair <input type="checkbox"/> Deteriorated

13. INTEGRITY (Location)			
<input checked="" type="checkbox"/> On original site	<input type="checkbox"/> Moved	WHEN?	(Alterations) IF YES, EXPLAIN
		<input checked="" type="checkbox"/> Yes <input type="checkbox"/> No	GLASSED-IN PORCH, LATER SASH

Three-bay facade, left entry, sash generally 6-over-6. Paneled wood door flanked by rectangular sidelights. Wide paneled entry pilasters. One-story full-width porch has square chamfered Italianate posts, plain frieze, molded cornice. Wide paneled corner pilasters, molded cornice with full return.

Right elevation has bay window with molded cornice on scroll-cut brackets. Left has large one-and-one-half story ell. Recessed porch on paneled columns is now glassed in.
